AH3000 BT7- Hardtop Restoration

By Lin Rose

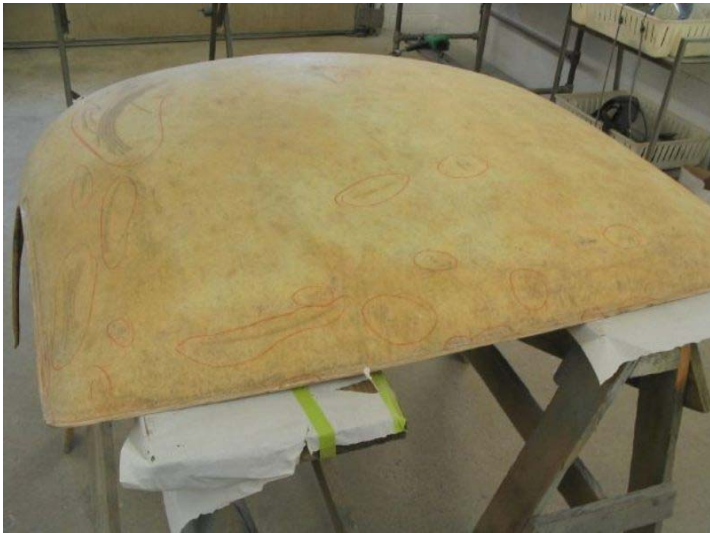
The fiberglass shell is very flimsy without the supporting aluminum hardware that serves as an external skeleton for the top. It had developed some cracks and blemishes over the years.

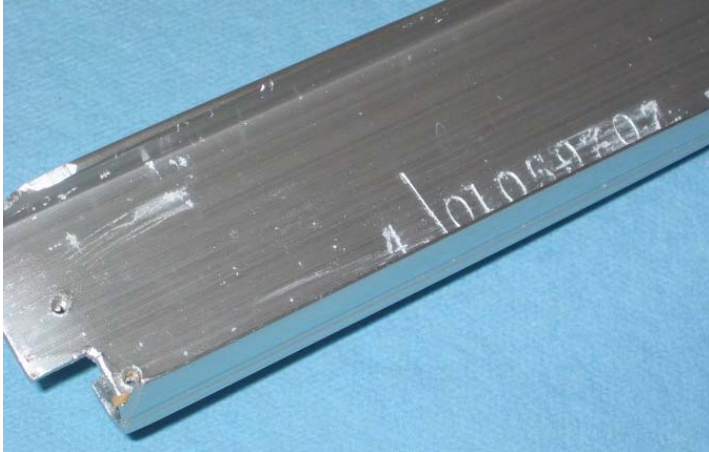
I cleaned up the aluminum framework as best I could including removing as much of the original clay/caulk/sealer that was possible from the mounting channels of the trim. The identification number for the hardtop and the assembly date is available on the right window cant rail.

I then sent the aluminum off to Ano-brite in California for further cleaning and anodizing. Everything came back sparkling and looking almost new. In the meantime, I ordered Bill Bolton's restoration kit that includes, headliner and trim fabric, rubber seals, foam pads, windlace, a new rear backlight and instructions. All high quality! Thanks, Bill.

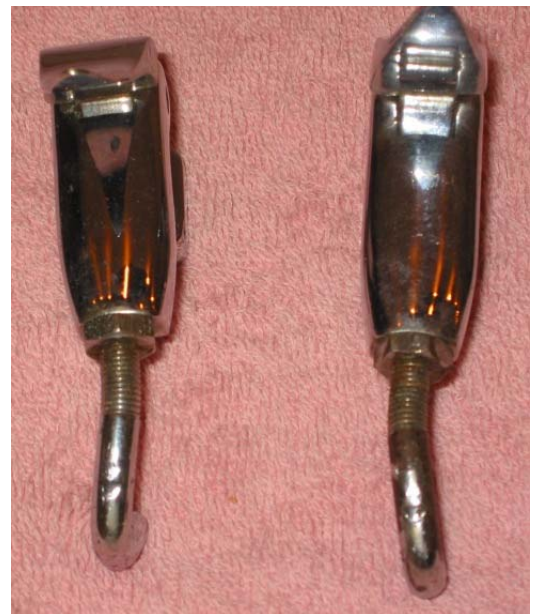
The chrome front catch set clasps were in pretty good shape and I decided against rechroming them. However the J hooks needed attention and I decided to just purchase new hooks from Cape International.

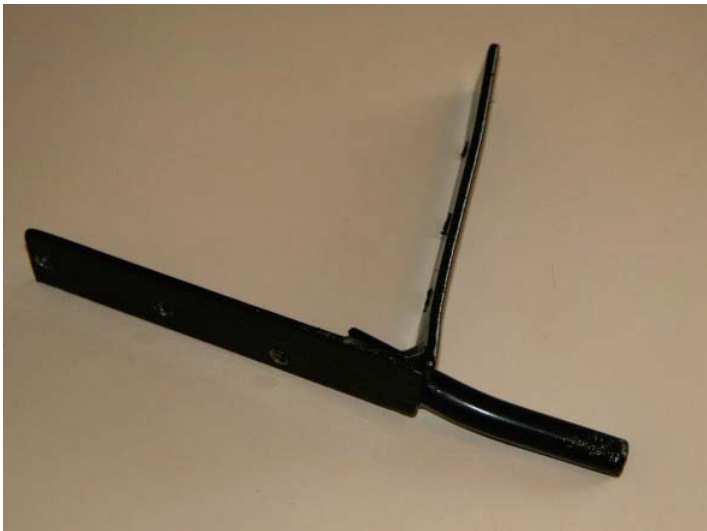
The steel locating spigots just needed some cleaning up and painting. They were painted black and new truss head stainless screws were purchased for assembly

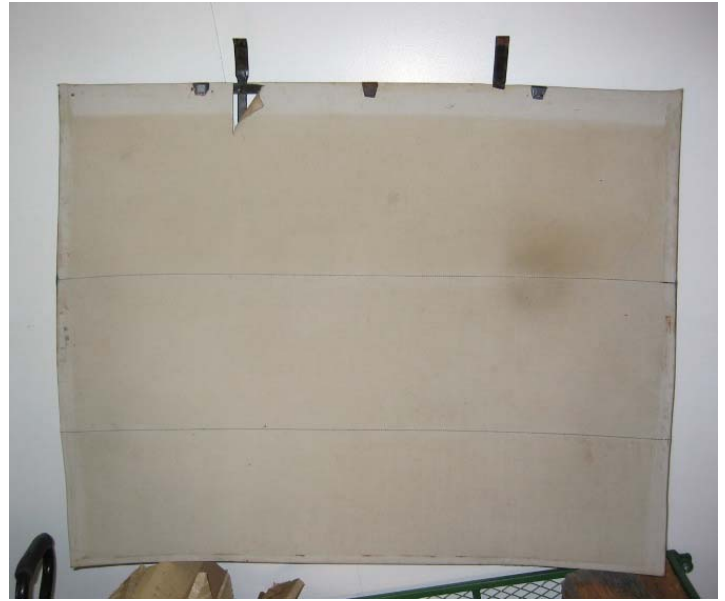
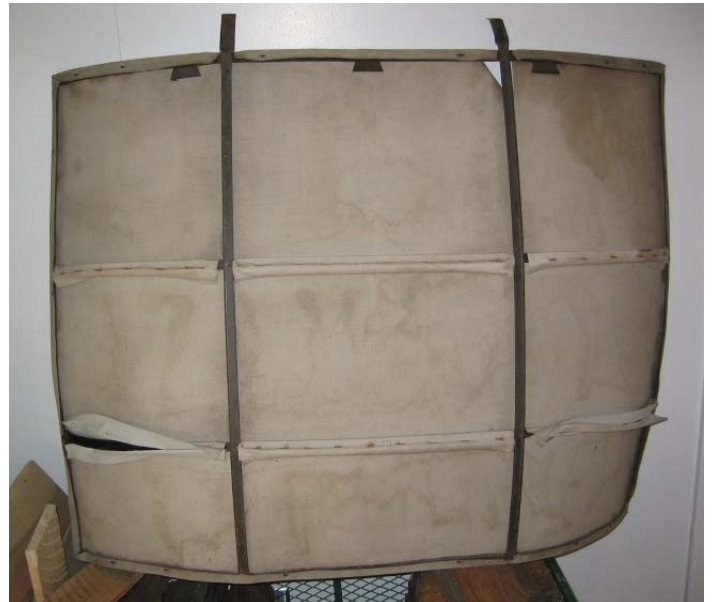
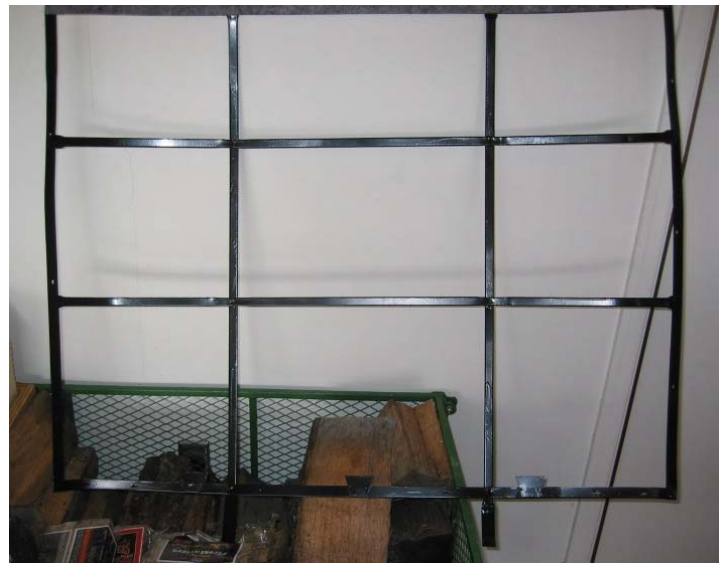
The headliner was torn and dirty and needed to be replaced. The headliner frame needed attention, too. It was a little rusty and the felt was in bad shape. The frame was painted black and new felt was glued in place.

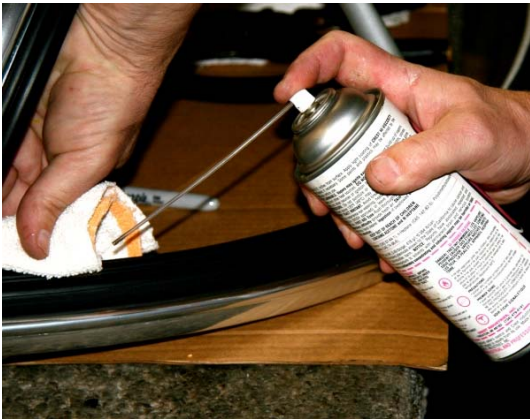
The installer used a silicon spray to temporarily soften and lubricate the rubber to make it easier to fit the plexiglass and the locking seal. Unfortunately, we discovered that my glass was not shaped properly.

I was able to compare it to my “foggy” original and one could see that trimming was required. As with the rubber, the rule was “a little at a time.” We taped the glass to mark the material to be removed and to avoid scratching it and then used a belt sander to gradually remove material. We repeated this process three times until satisfied with the fit.

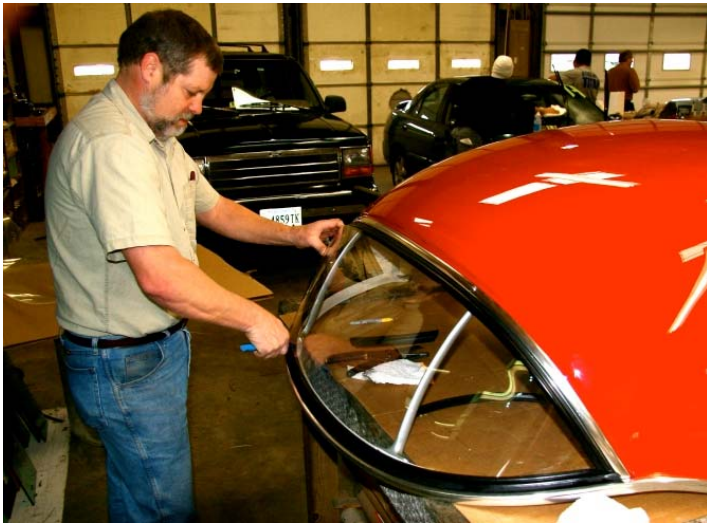
We experienced a little problem with the lower locking strip - it just did not want to “lock” on the bottom edge of the strip. The shop had another, slightly larger, strip that worked, but it had a chrome finish. I will paint the

chrome a matte black to look just like the rubber. The plastic tool in John's hand is known as a "bone."

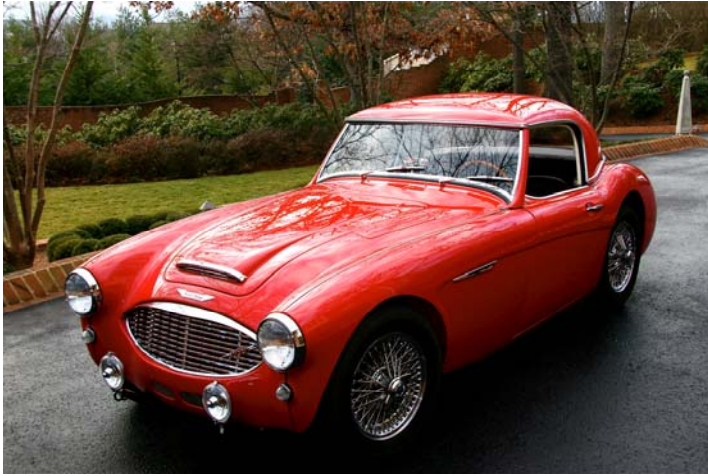
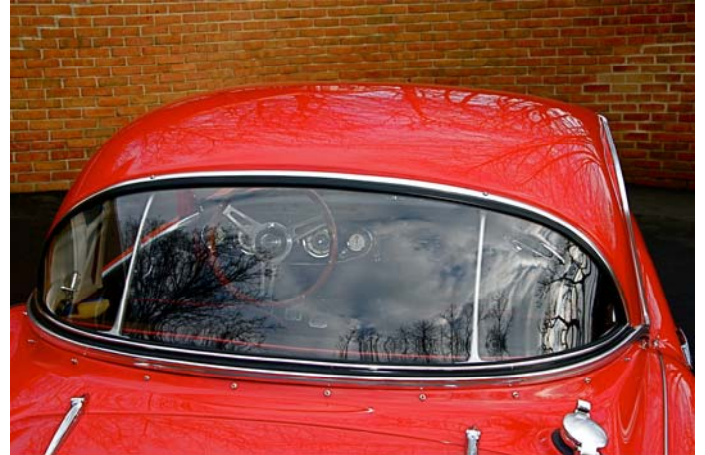
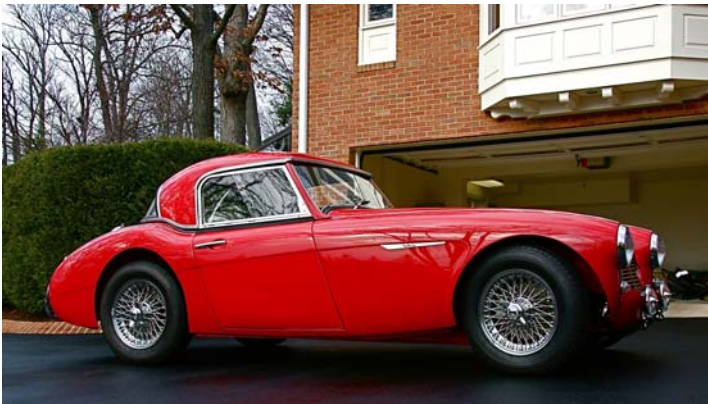
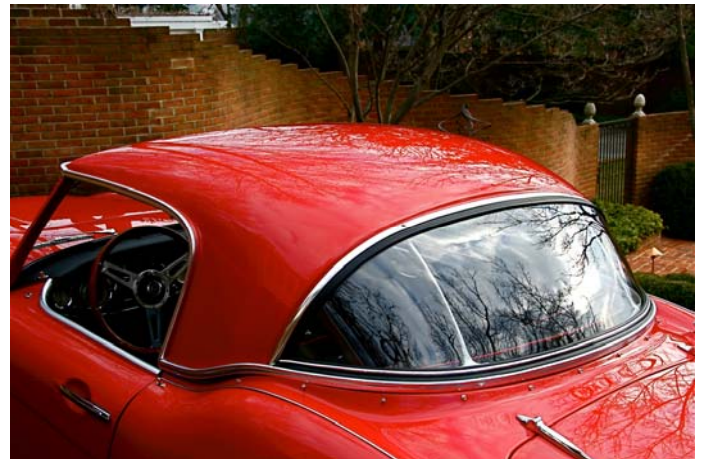
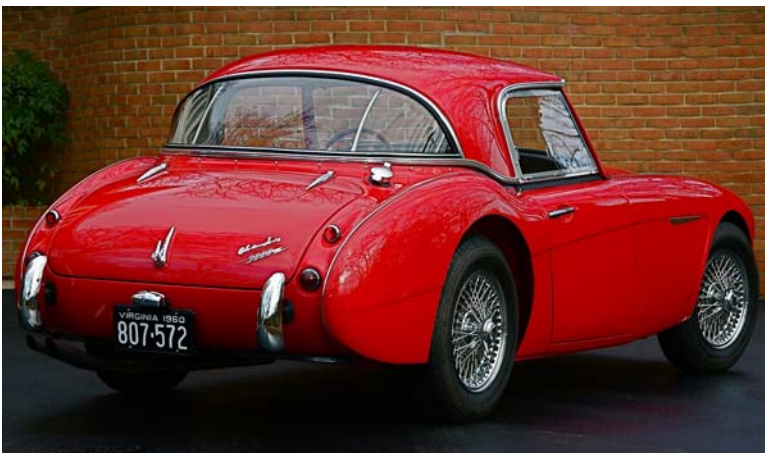
These are some images of the top on my car. It took some time to get the top to fit well with the cockpit molding. I still have a slightly larger gap at the top quarter panels than I want so I will continue to try to refine my fitting.
