From the Healey mailing list
01 October 2005

Hello, I'm having trouble understanding how the rubber door to scuttle seal fits on my BN7. These seals are from Moss. I believe they are imported from England. Bill Bolton doesn't have any more of his to sell. The questions is about the flap that appears to extend over the top of the metal dash and under the end of the padded wood dash pad. Is this flap really needed? It doesn't appear to provide any sealing surface contacts. It raises the end of the dash pad up. I can't find any photos in any of my books that show the end of the dash pad being so high above the edge of the door. Is that the way it is suppose to be or are these rubber seals just bad copies of original seals (and I trim this flap off). As always, any help will be greatly appreciated.

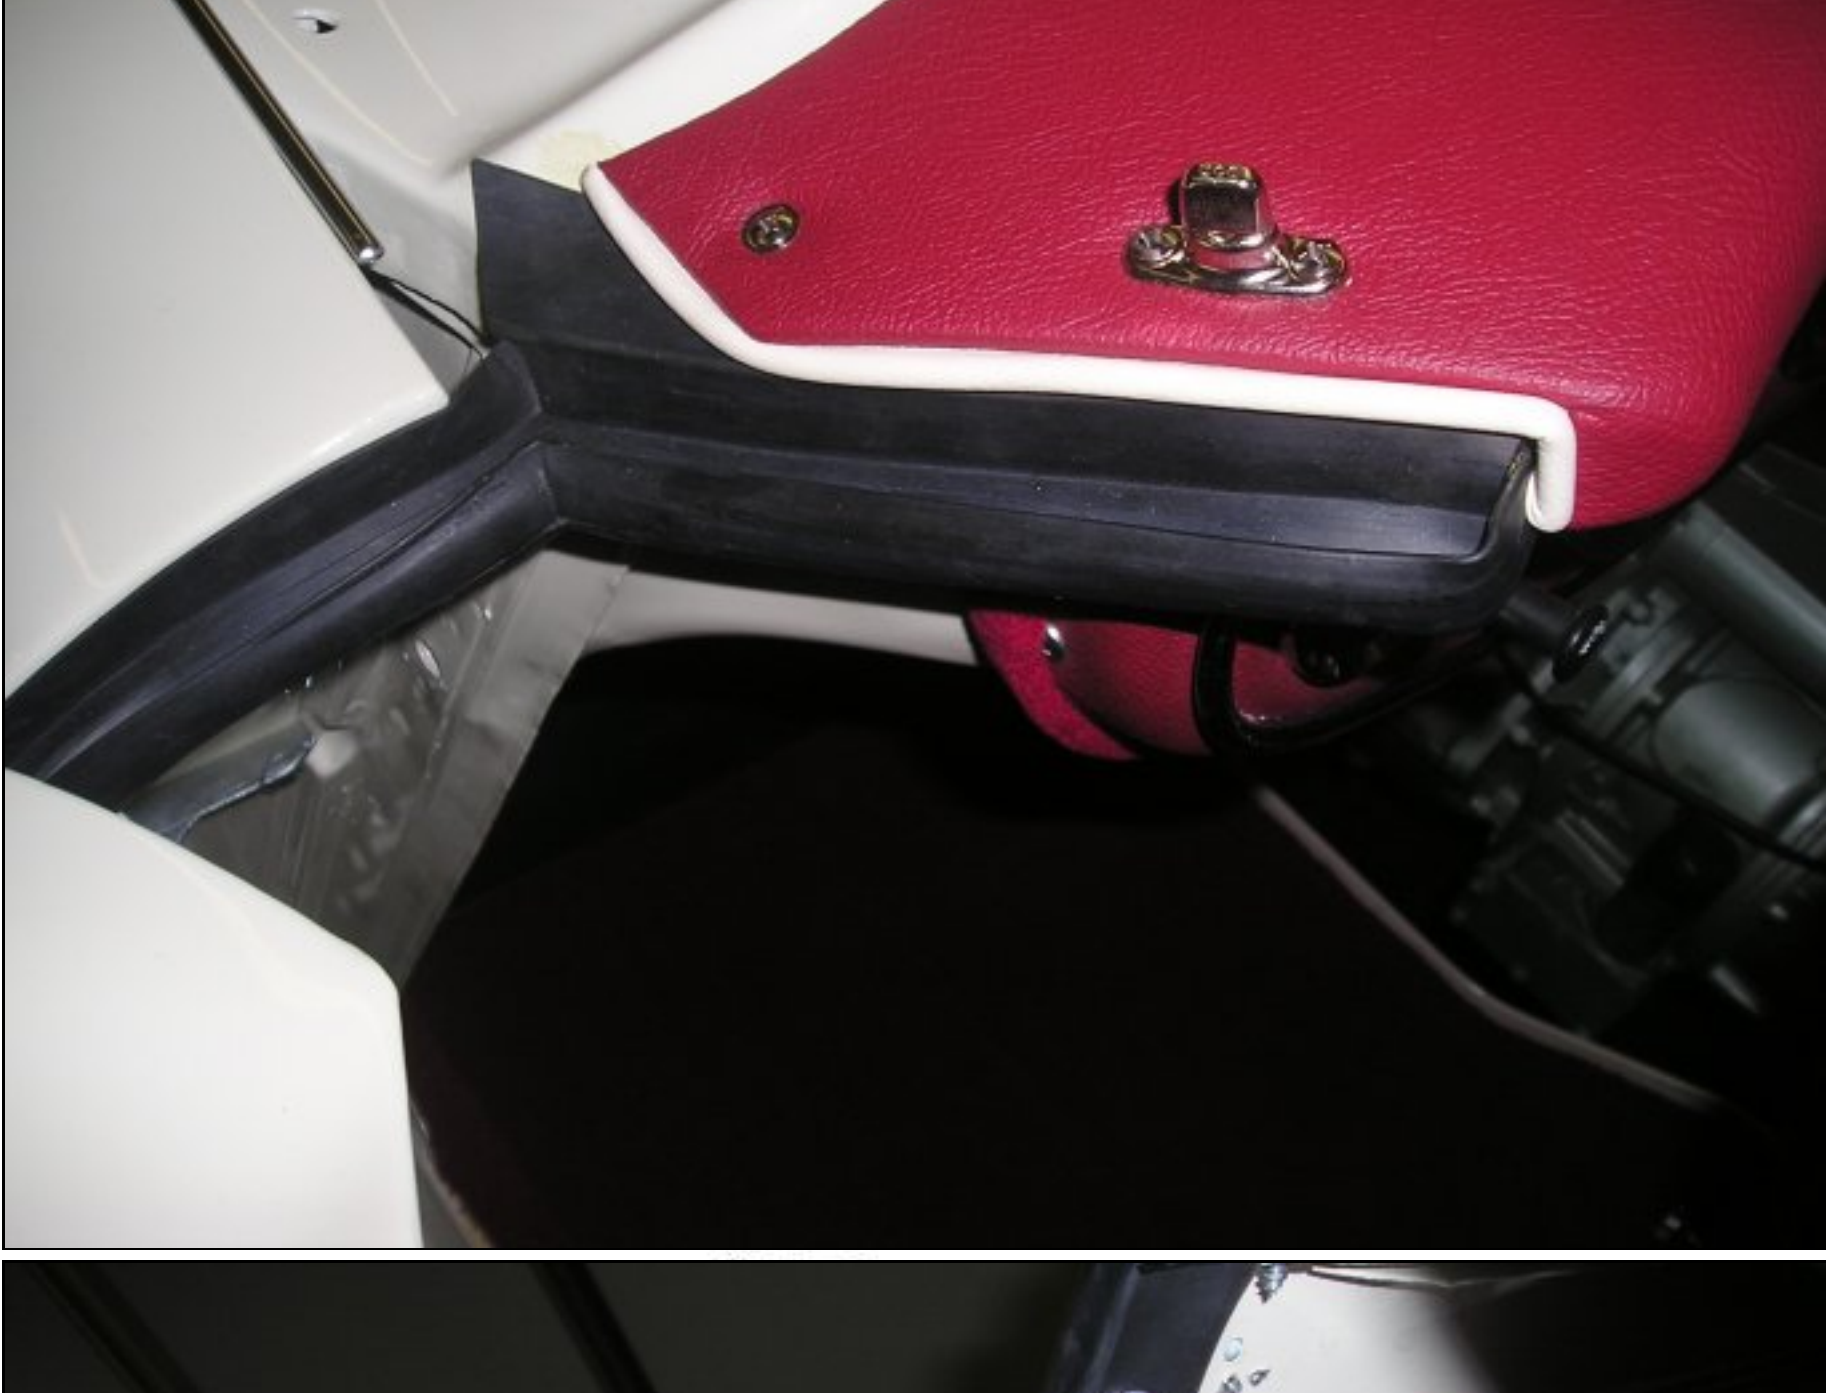
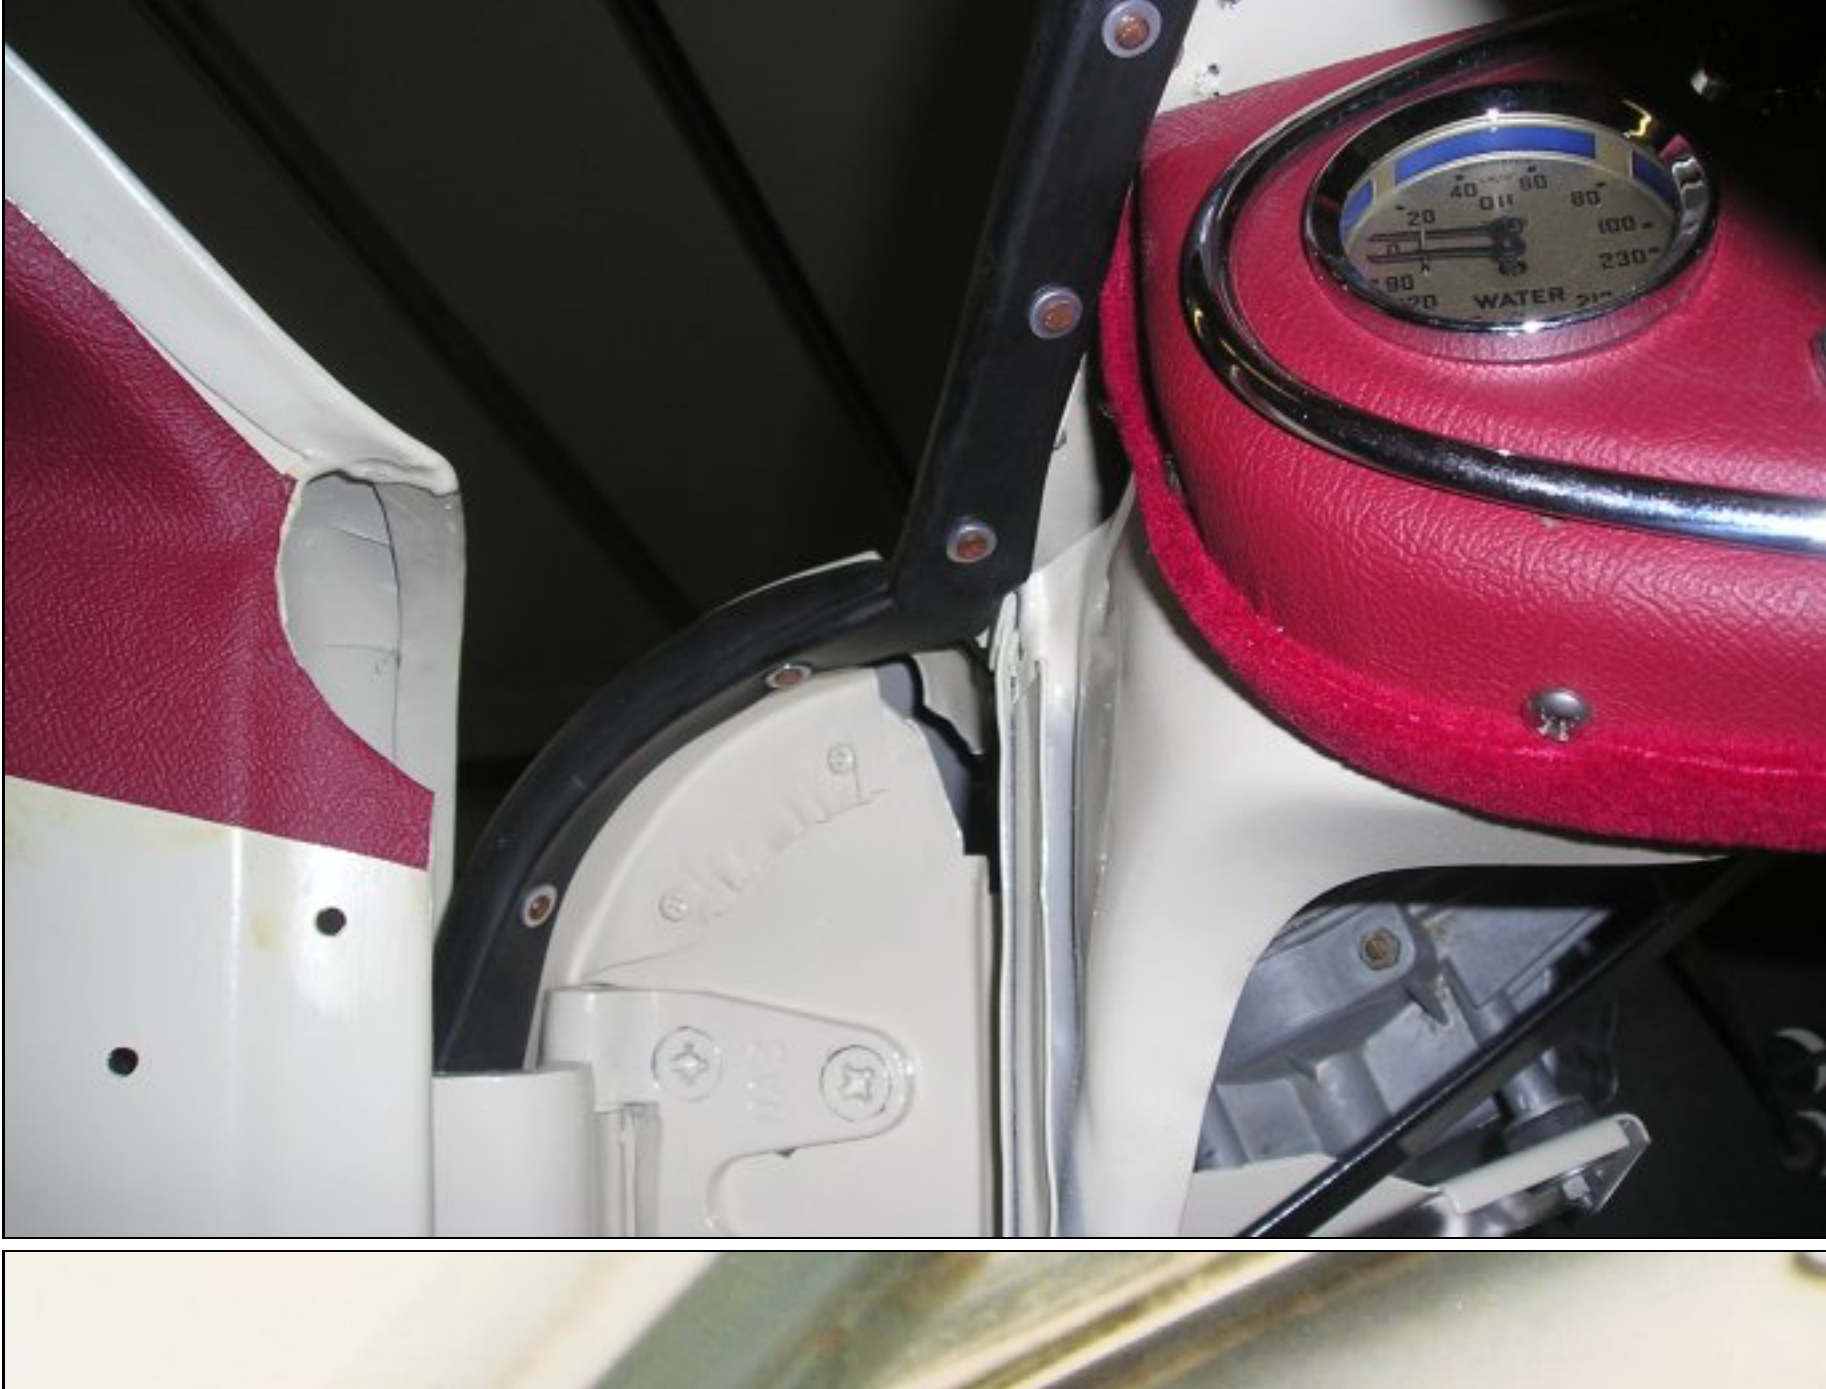
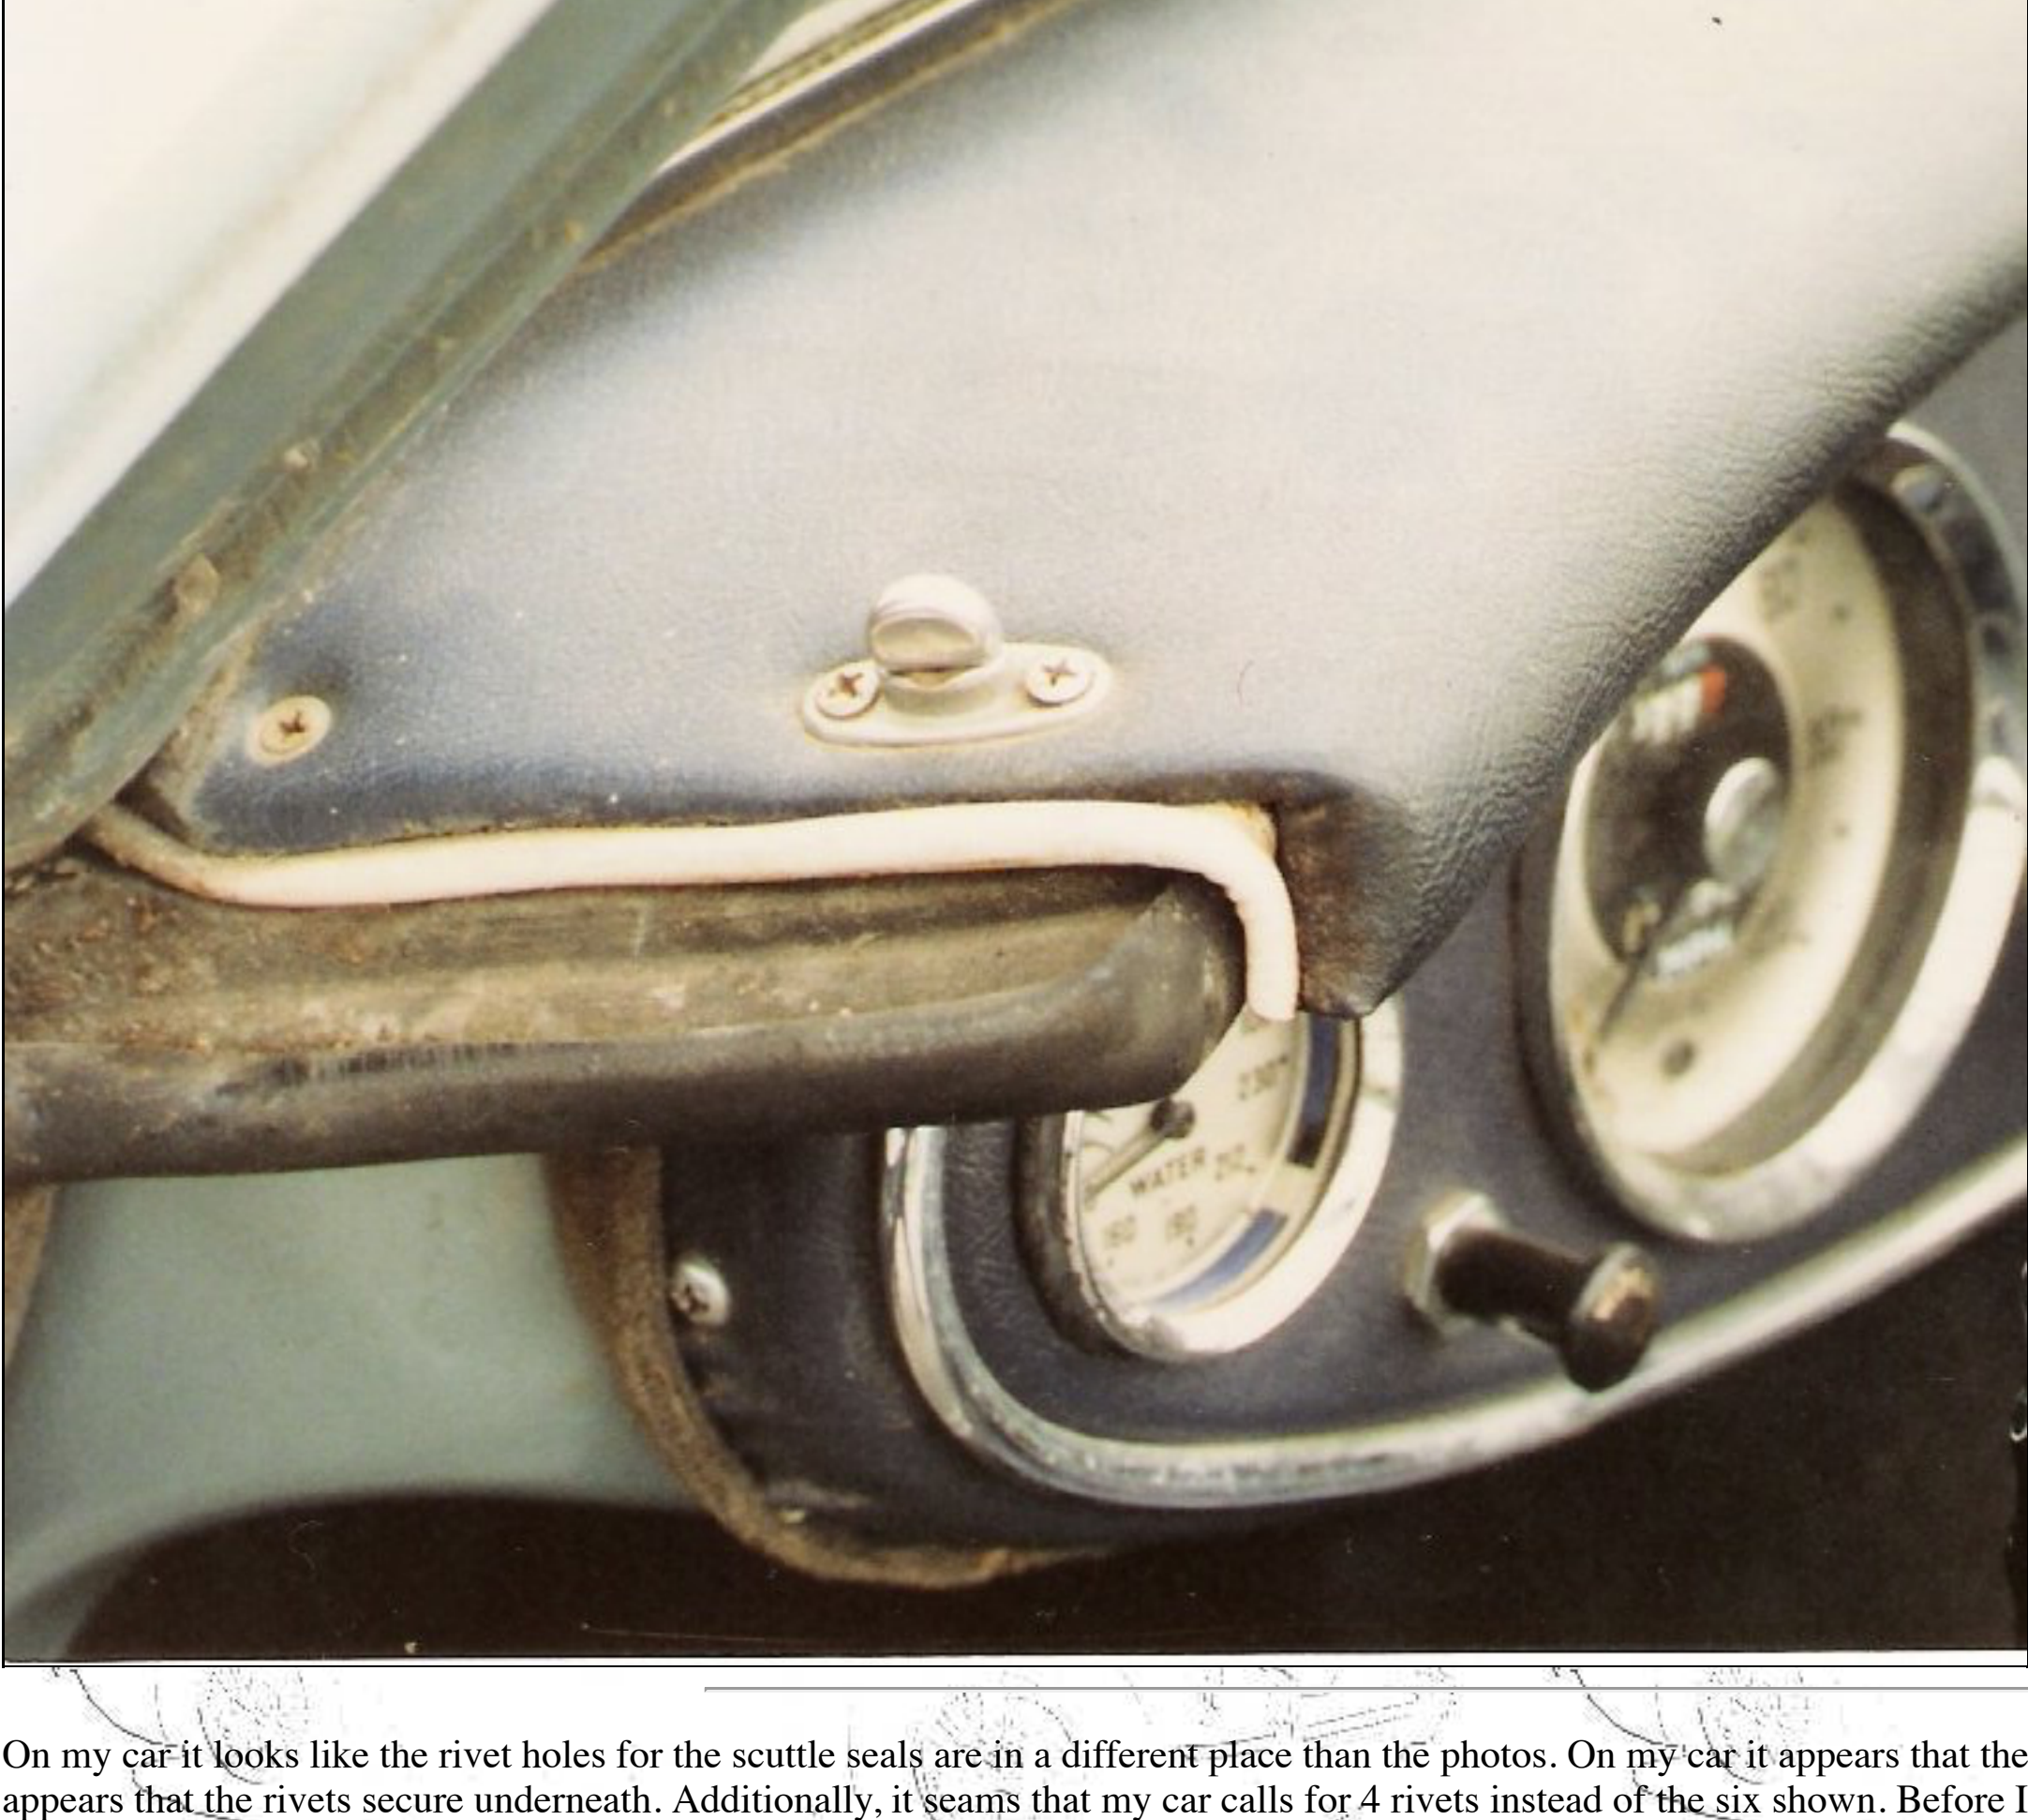
I'm attaching pictures but these are of Bill Bolton's seals. Note the view from the underside showing the split rivets and washers that fasten the lower flap of the assembly to the front wing flange and the scuttle flange. I'm also including a picture of an original installation. I hope the same installation can be done with the ones you have.

The upper flap is really needed to secure the thing tightly to the scuttle surface. It should be only thin , maybe 1/16" thick, so shouldn't be noticeable under the dash pad. With the windscreen assembly off the car the upper flap needs to be contact cemented to the upper surface paying attention to make sure the edge runs exactly parallel to the edge of the scuttle. The contrasting dash edge piping should come smoothly and evenly to the edge of things to complete a tidy installation. The forward locating screw and the 2 turnbutton screws will locate the dash top panel and run through the glued flap into the metal beneath.

If you cut it off, that edge has no means of sealing and keeping water from creeping in behind, and the shape of the finished installation will be ruined.

Keep in mind the end needs to be trimmed away to leave only a strip of rubber that will wrap over the end (to form the blind end of the trough) and tuck under the dash pad, with a single screw locating it onto the edge of the shroud panel.

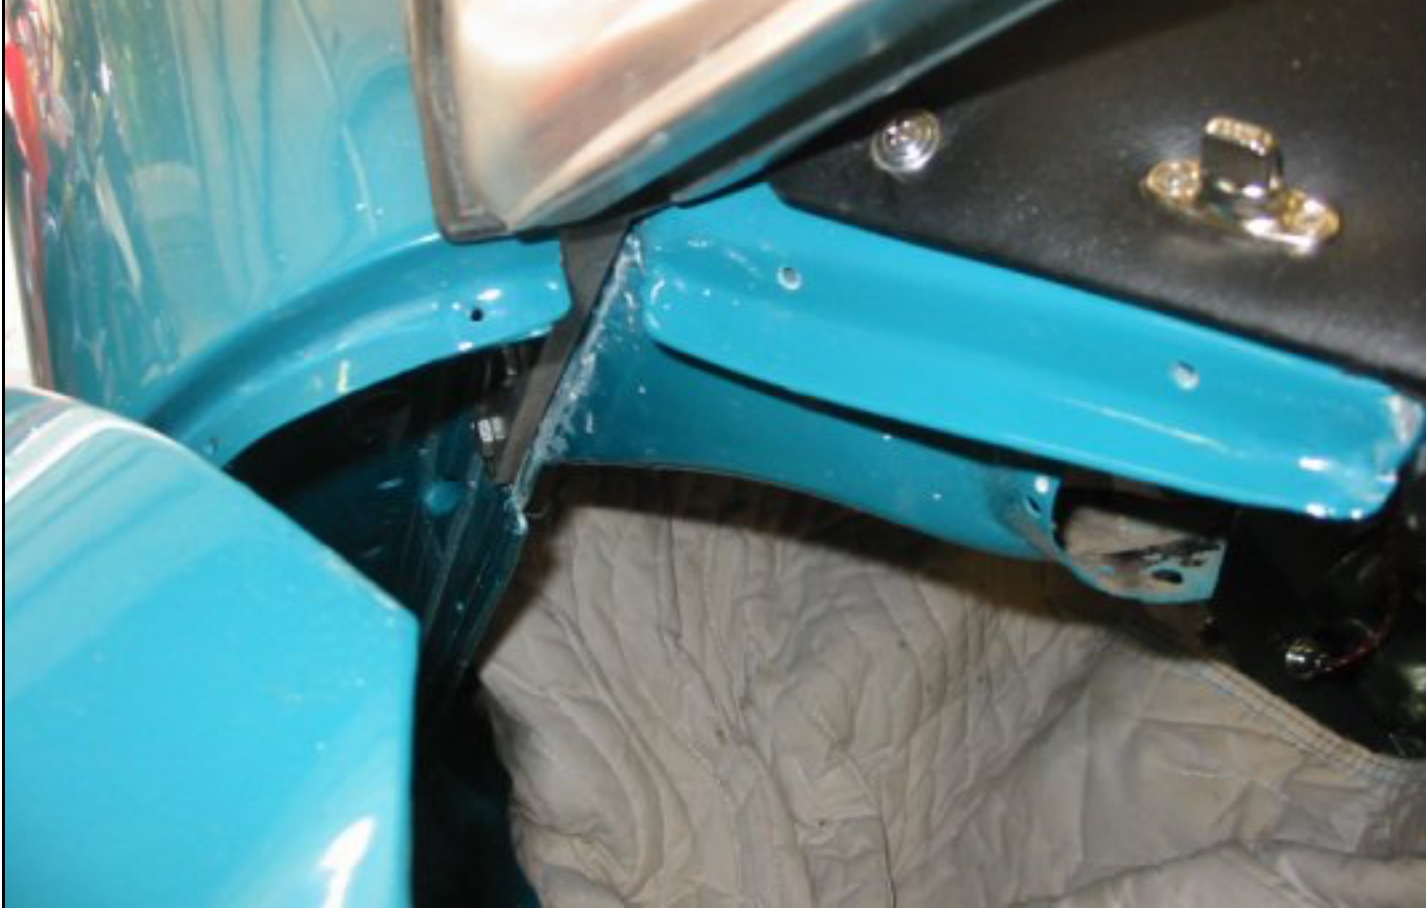
On my car it looks like the rivet holes for the scuttle seals are in a different place than the photos. On my car it appears that the rivets go in from the side, but in the pictures, it appears that the rivets secure underneath. Additionally, it seems that my car calls for 4 rivets instead of the six shown. Before I pull the windshield back off, I want to make sure that it is OK to secure these from the side.

I'm not sure on this but I don't think the scuttle seals were fastened from the side. The two holes you have there look like the rivet holes to fasten the shroud flange to the inner steel structure underneath.

Is it possible that your shroud flange had holes in it that have been filled or repaired?

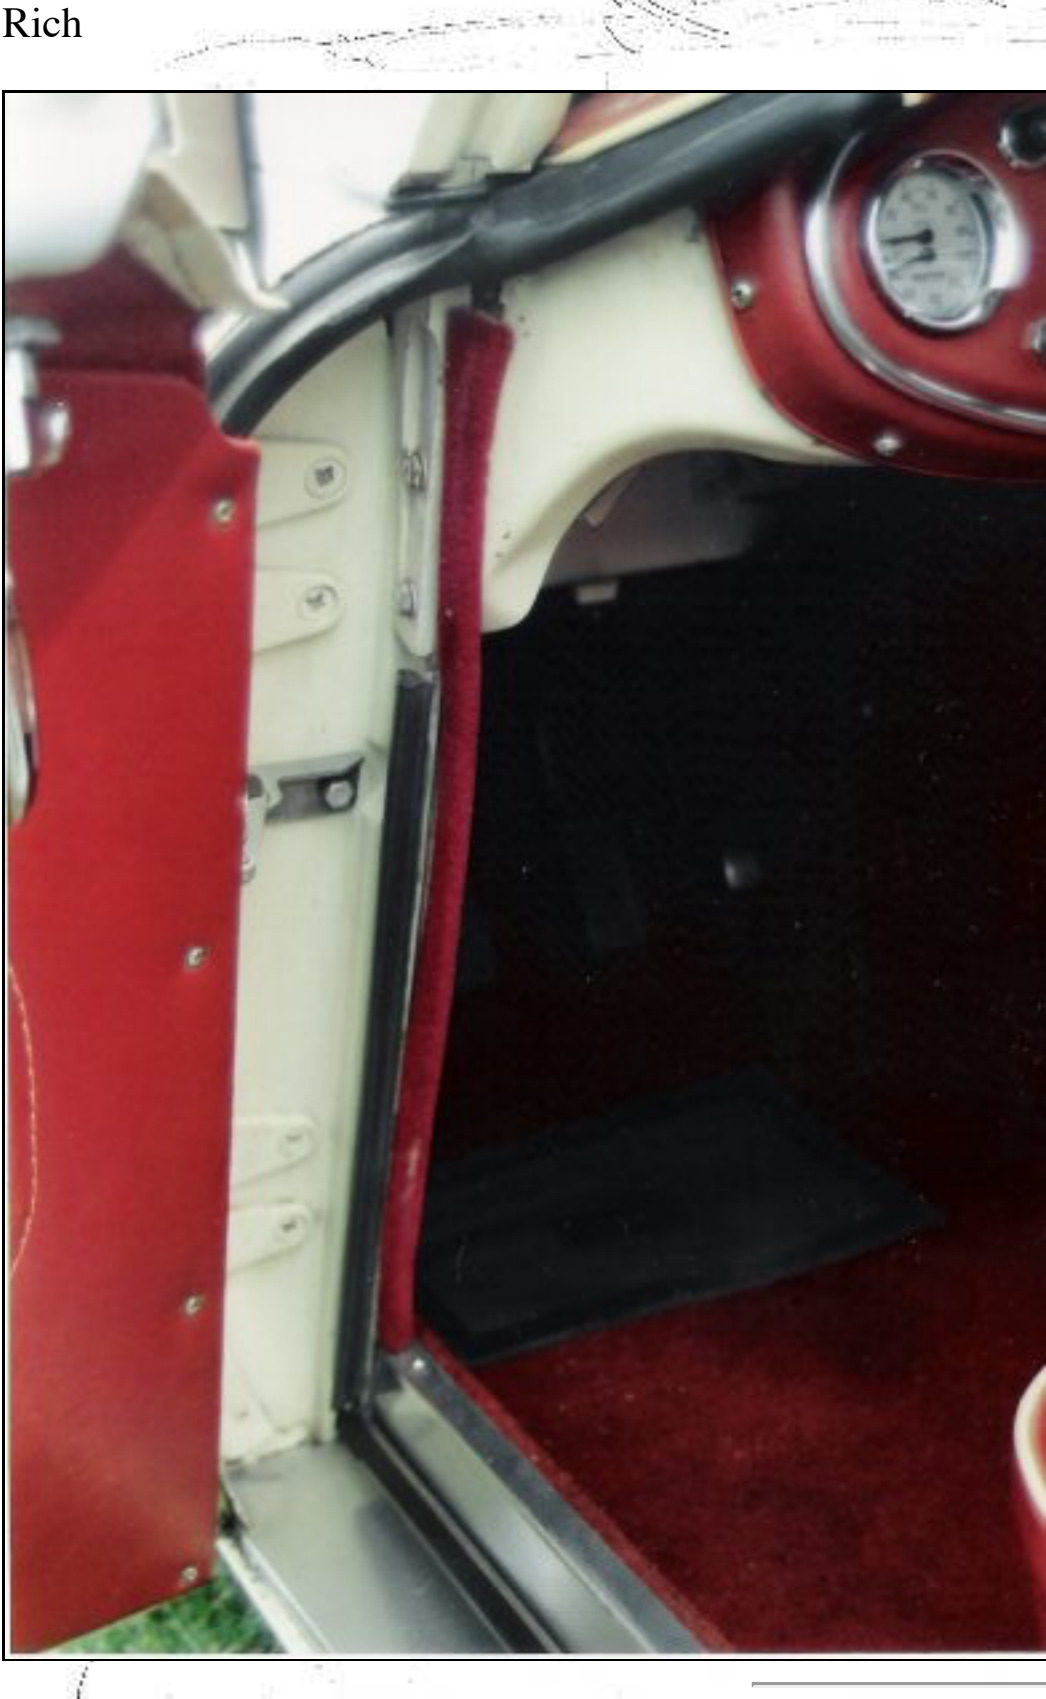
The third picture is of a Longbridge 100/6 showing it's scuttle seal and below is the one from an early 3000. It's hard to determine but I believe they had the same design seal. This would have been a new design to greatly improve matters compared to the one evolved for the previous model, the BN2. For the first time a rear flange of the front fender was introduced to mount that portion of the new scuttle seal. I'm pretty sure the riveting continued onto the shroud flange too.

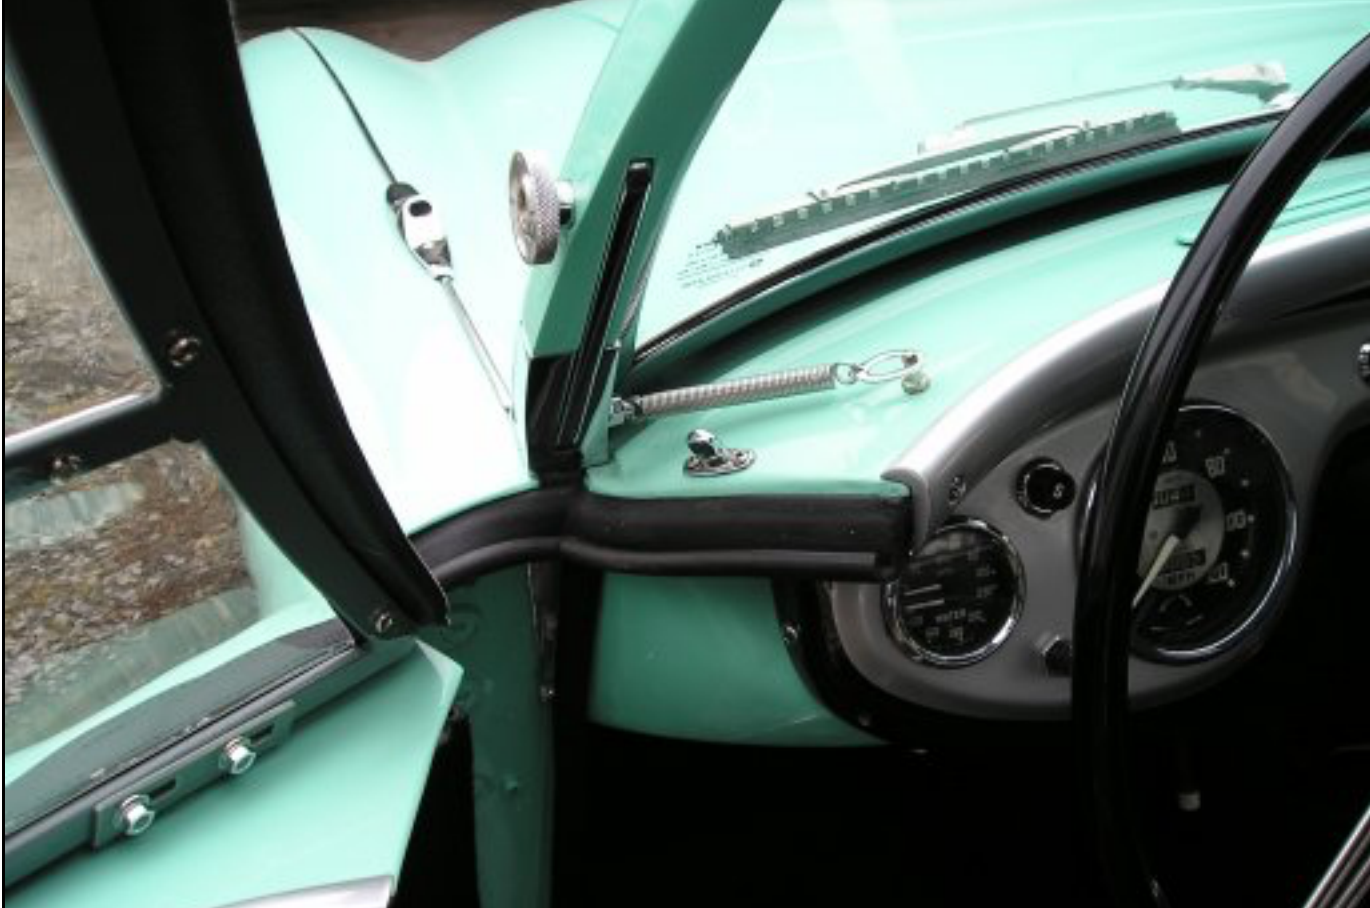
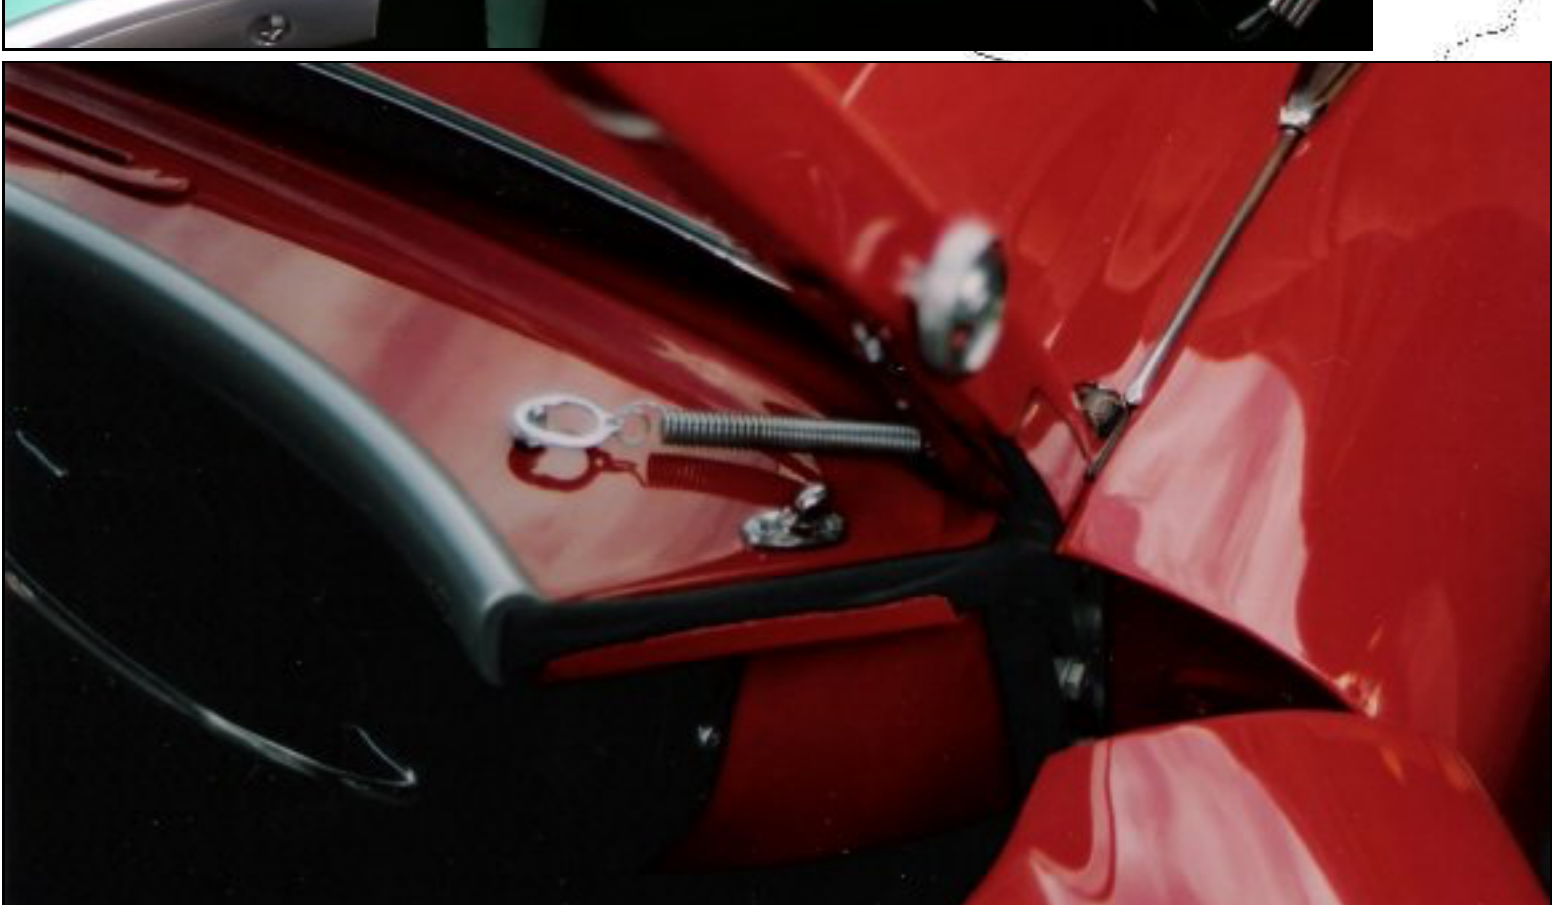
According to the factory parts list the later scuttle seals with their accompanying mounting brackets were fitted comencing with car #229180, Body 11143 in November '55. See picture with Florida Green car. Prior to that the seal here was a simple rubber strip captured in the U channel as per the Carmine Red car.
