AH3000 BT7- Hardtop Restoration

By Lin Rose

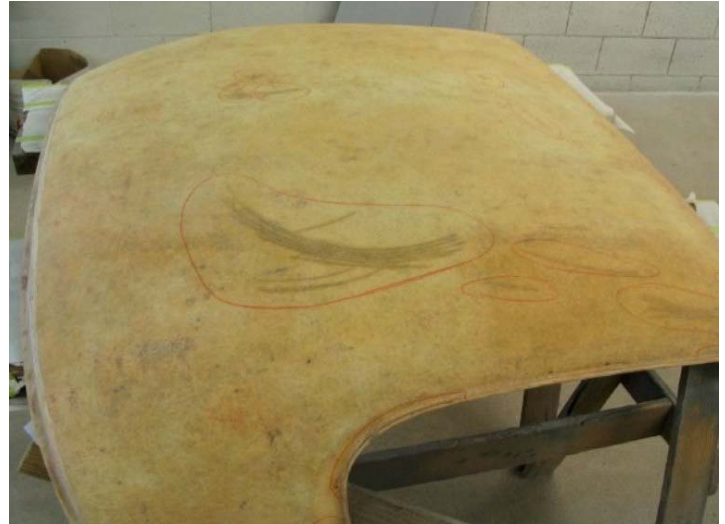
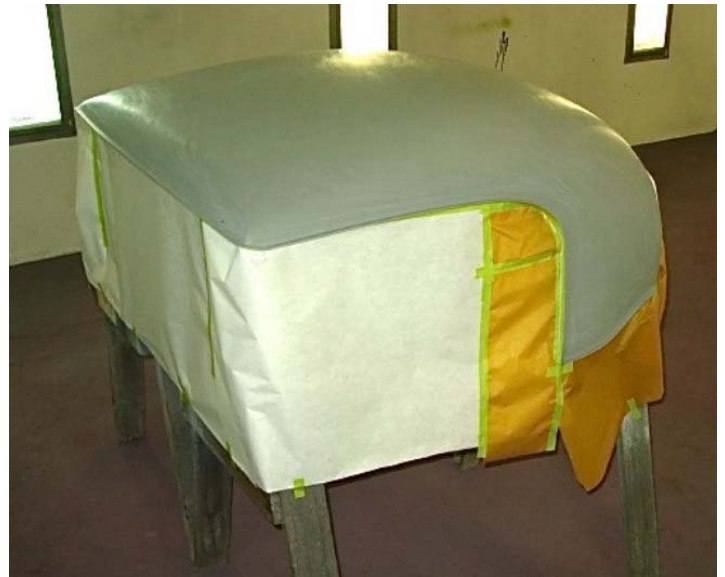
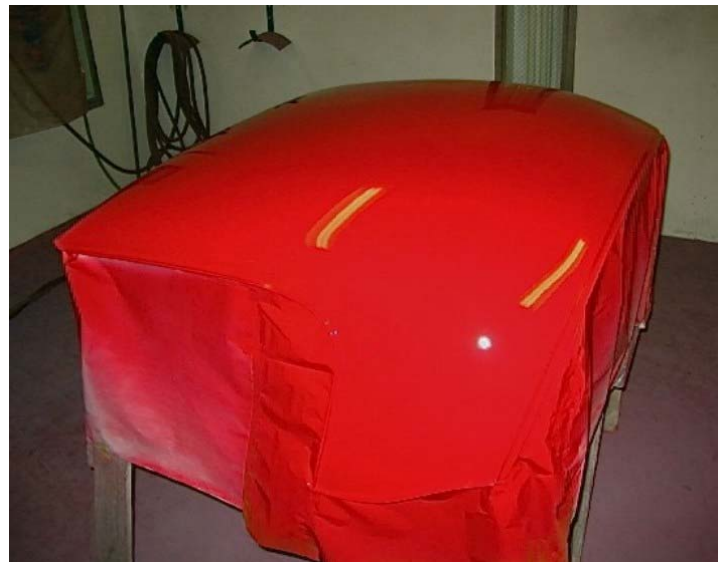
The fiberglass shell is very flimsy without the supporting aluminum hardware that serves as an external skeleton for the top. It had developed some cracks and blemishes over the years.

I cleaned up the aluminum framework as best I could including removing as much of the original clay/caulk/sealer that was possible from the mounting channels of the trim. The identification number for the hardtop and the assembly date is available on the right window cant rail.

I then sent the aluminum off to Ano-brite in California for further cleaning and anodizing. Everything came back sparkling and looking almost new. In the meantime, I ordered Bill Bolton's restoration kit that includes, headliner and trim fabric, rubber seals, foam pads, windlace, a new rear backlight and instructions. All high quality! Thanks, Bill.

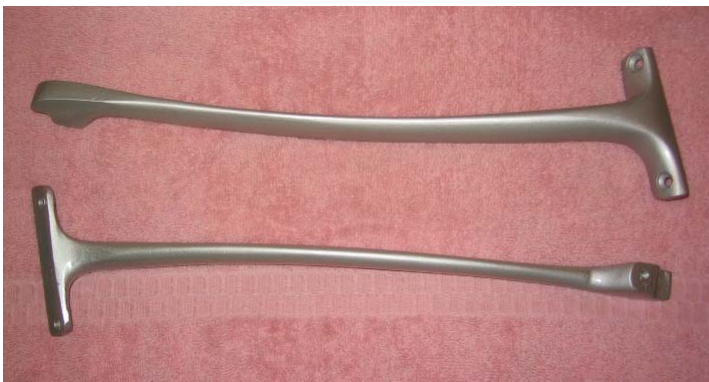
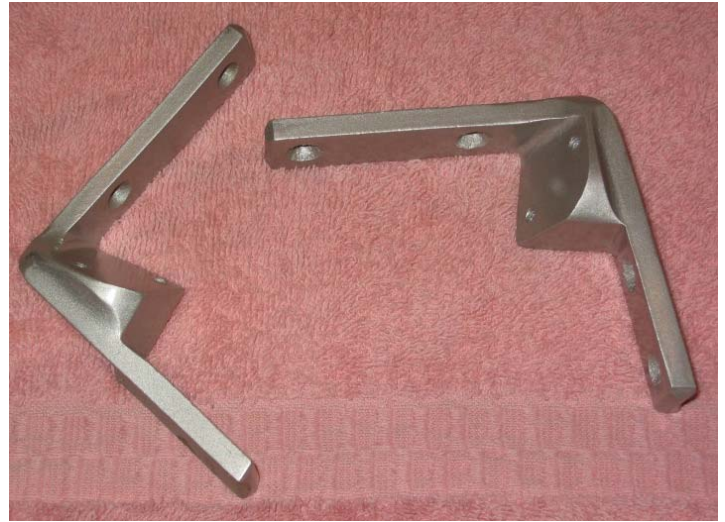
Cleaning up and refinishing several of the hardtop components was next on my list. The vertical rear aluminum braces and the front corner brackets were sanded and painted a dull aluminum that closely matched the original color.

The chrome front catch set clasps were in pretty good shape and I decided against rechroming them. However the J hooks needed attention and I decided to just purchase new hooks from Cape International.

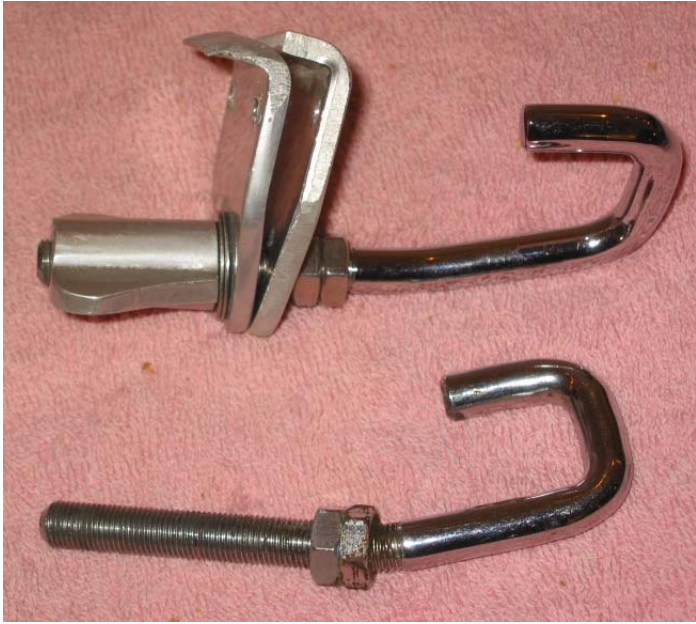
The rear mounting hook/plate/wing nut assembly was also in good shape but I did decide to replace the hooks and again sourced them from Cape International. I ordered new mounting plates, but like the shape of the originals so I will stick with them.

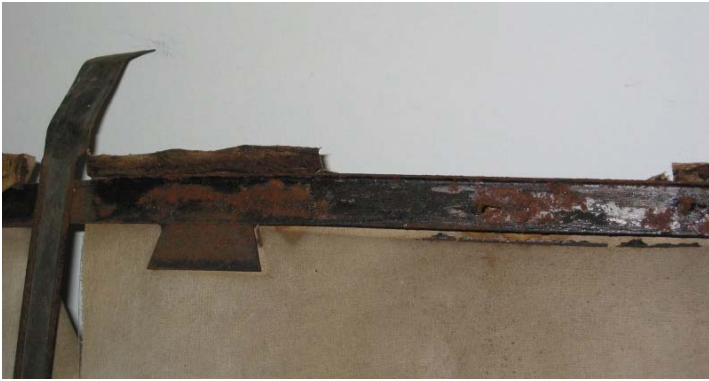
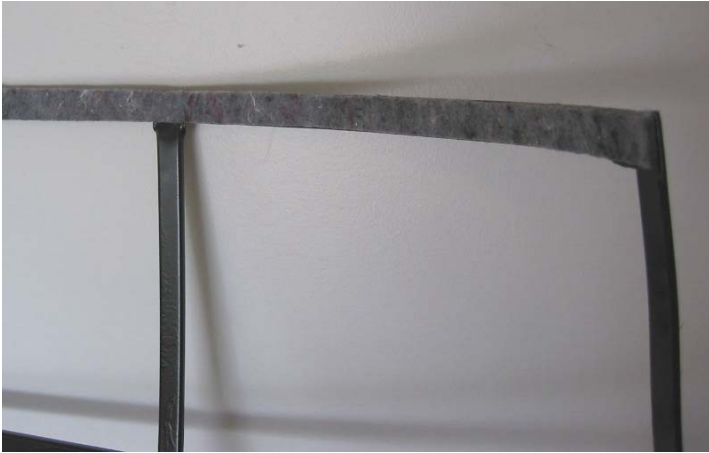
Glued fabric to the bottom cant rail.

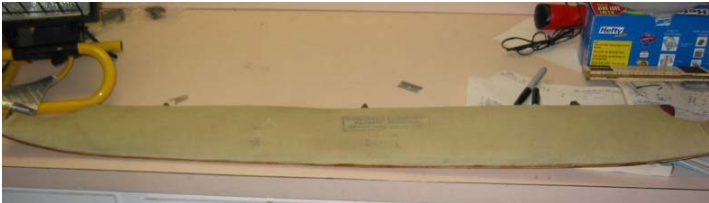
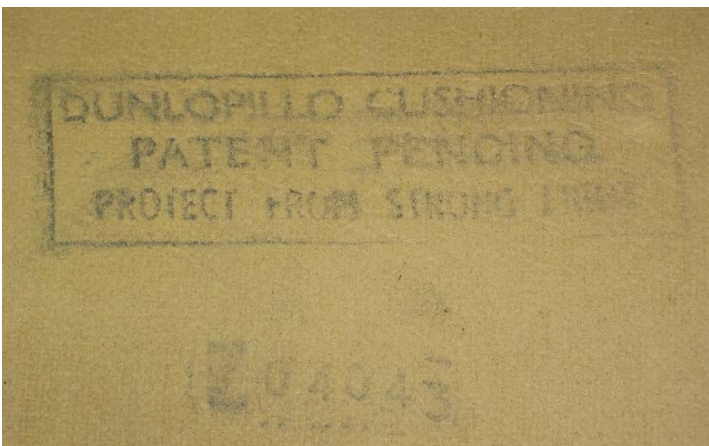
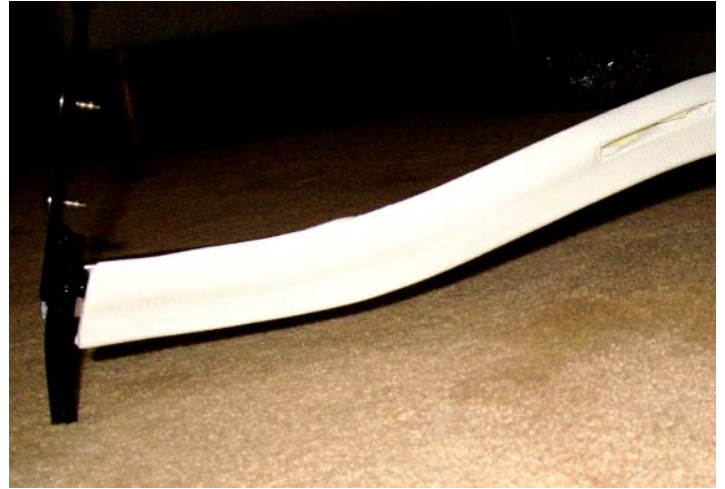
I was surprised to find the foam of the front pad in excellent condition after removing the headliner fabric. I don't know Italian, but it appears that the Dunlop foam rubber was manufactured (or at least the pad was) in Italy.

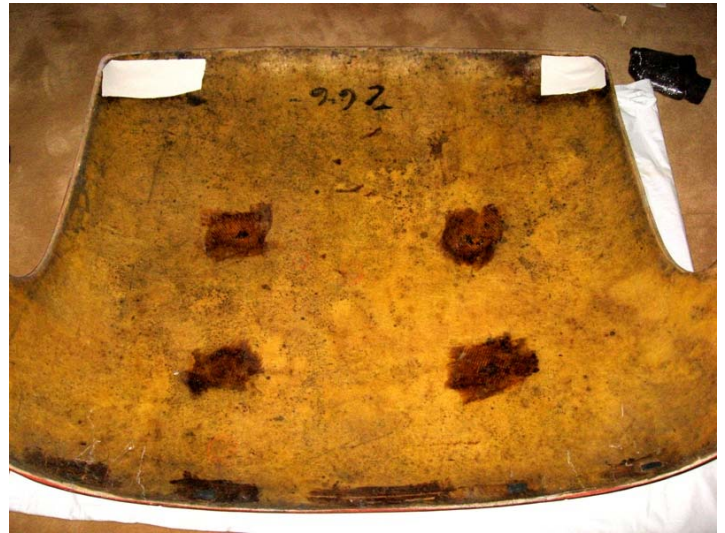
Glued fabric to the inside corners of the top shell.

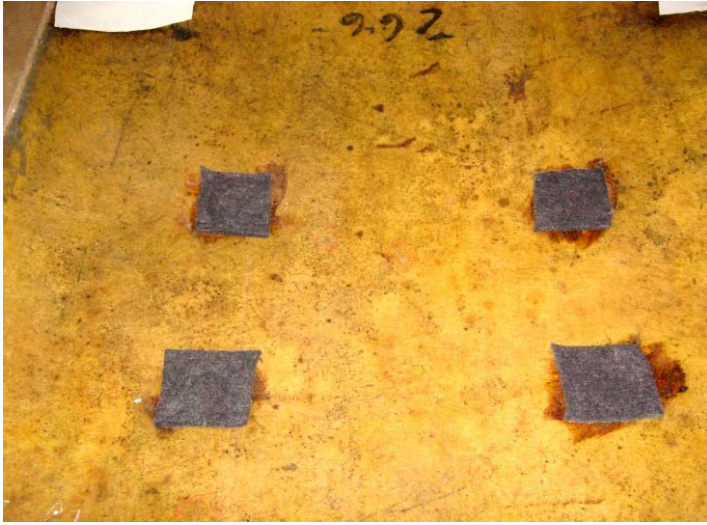
Glued carpet felt to four locations on the underside of the hardtop shell. This buffers the headliner metal frame from the fiberglass shell.

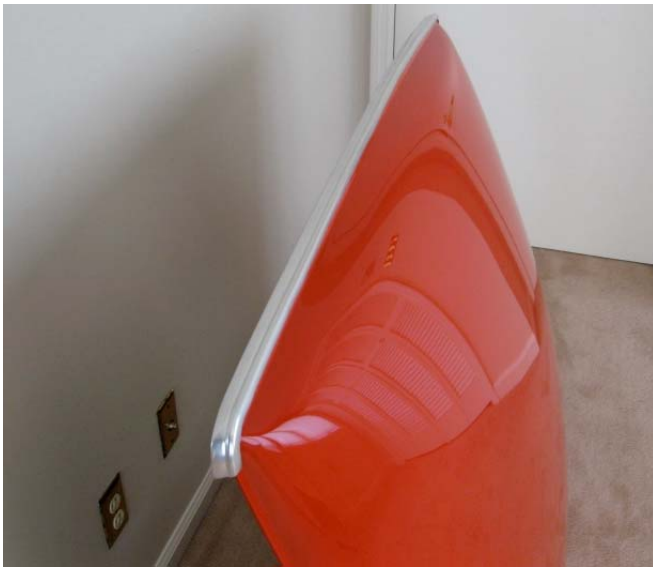
Applied 3M caulk to the channel in the front rail and pushed it onto the front lip of top shell.

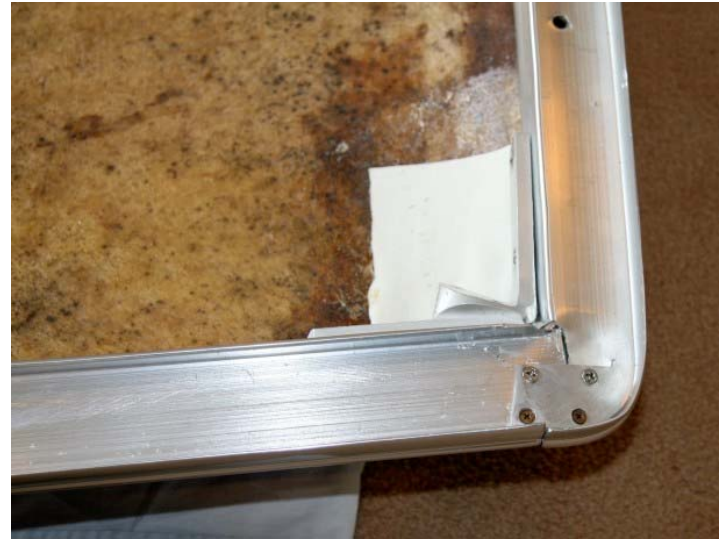
Applied 3M caulk to the channels of the side cant rails and pushed the rails onto the top shell. Temporarily screwing in the corner braces and the small aluminum plates helped pull the side rails into place.

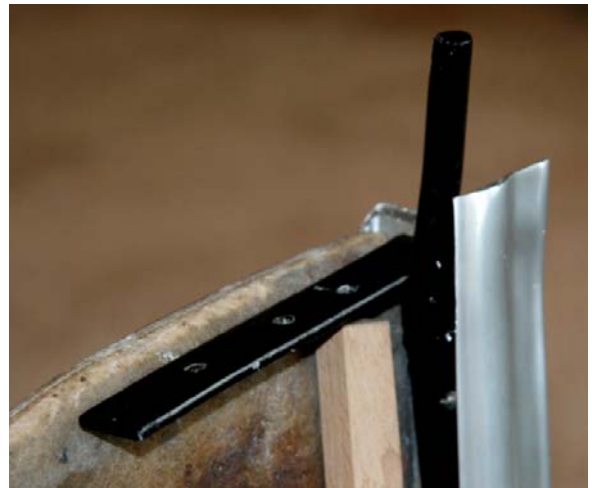
With the top upside down, the locating spigot pins were dropped into place, but not secured until after the bottom cant rail was pushed onto the top shell.

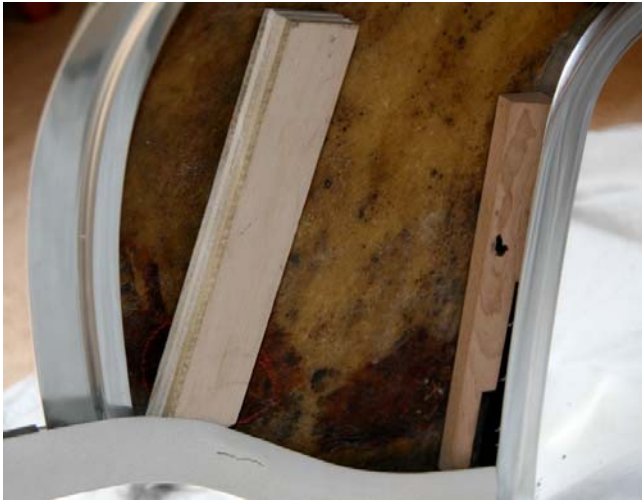
Applied 3M caulk to the channels in the bottom cant rail and positioned the rail on the top shell. This job requires two people! After properly aligning the rail, six stainless truss head screws can be screwed into place through the side and bottom cant rails into the steel spigot pin.

Applied a thin coating of the 3M caulk to the channel in the aluminum trim for the top of the backlight and pressed it onto the top shell. Again, two people really help with this task.

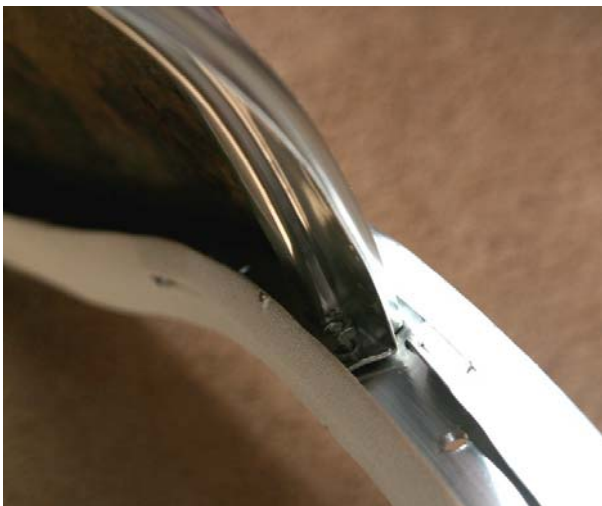
I then used a block of wood on each side of the top to spread the top toward the outside of the bottom cant rail and inserted two #10 stainless truss head machine screws with washers and nuts to link the bottom cant rail to the backlight top aluminum trim. After tightening the fasteners the wood spacer blocks were removed.

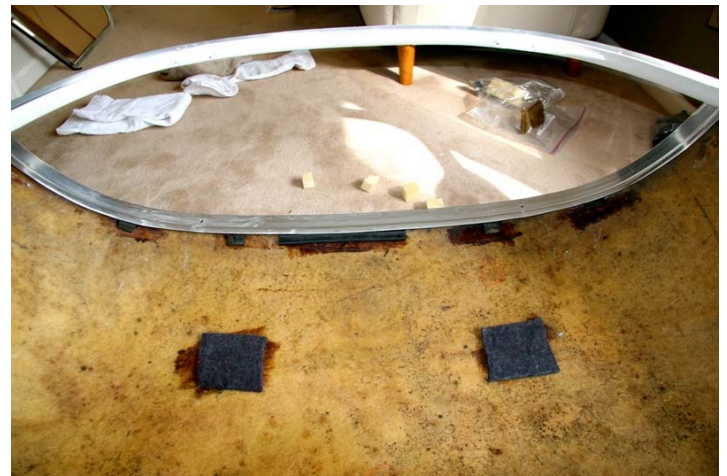
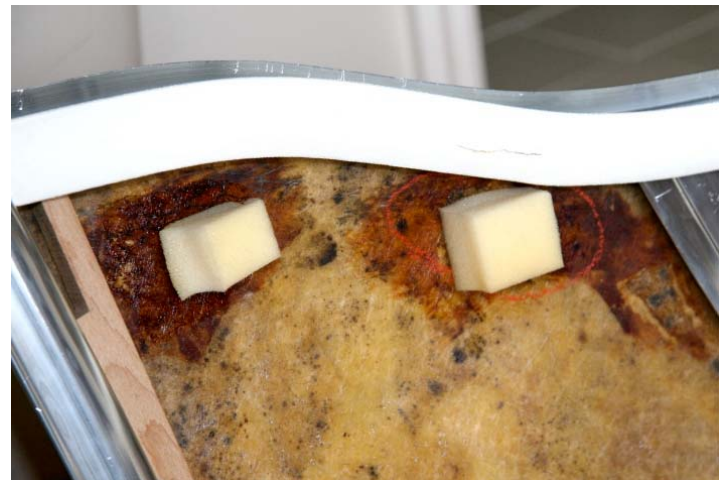
I had saved the five small original rubber seal pieces that were used as spacers/cushions between the headliner and the upper backlight aluminum trim. These were glued in place at the same locations on the inside of the top shell.

Bill Bolton's kit included 4 small blocks of foam padding (two on each side) that I glued to the interior sides of the top shell. These pads are used to force the upholstered quarter panels against the side and bottom cant rails. The original part number for these pads is 27H9592. Again, I could see where these pads were glued to the shell originally and they were cemented to the same locations.

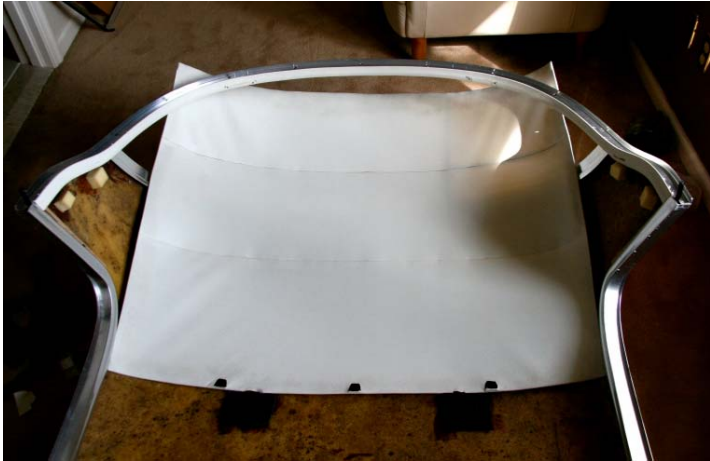
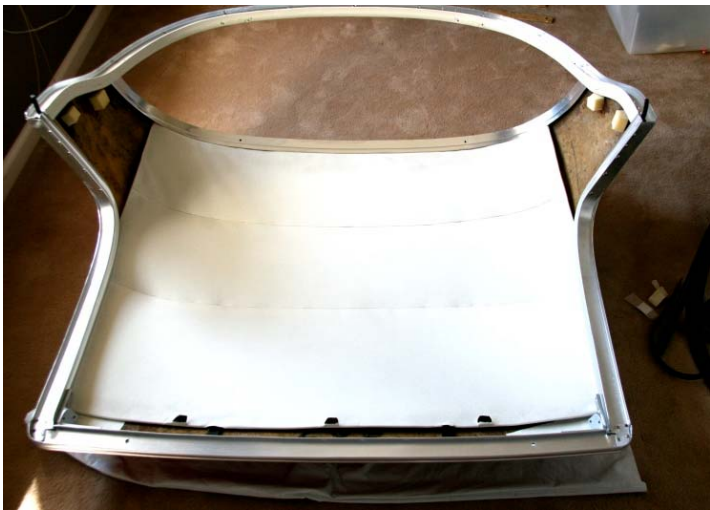
The headliner frame with new fabric supplied by Bill Bolton and sewn to the frame by a local shop, Classic Upholstery, was then inserted through the backlight opening and pushed into place. The metal clips at the front of the headliner were pushed under the front aluminum rail, and the rear edge of the headliner was pushed in place between the backlight upper aluminum

trim and the rubber cushions that had been glued to the the shell.

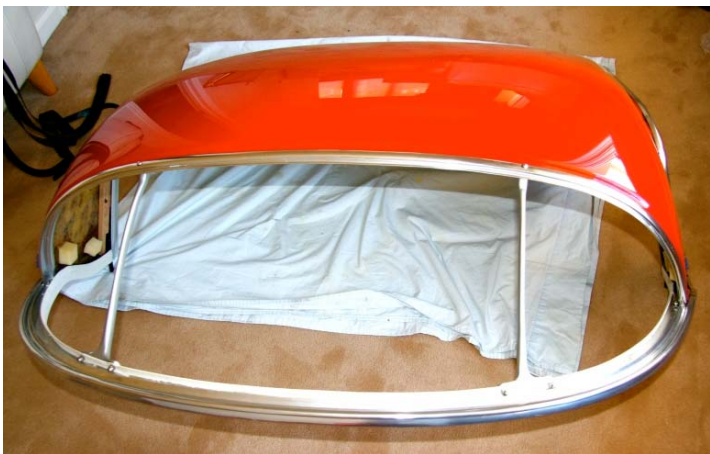
The aluminum backlight braces were then installed. I stuck 3M body caulk under the heads of the two chrome machine screws that went through the backlight upper aluminum trim and into the braces to help seal out water.

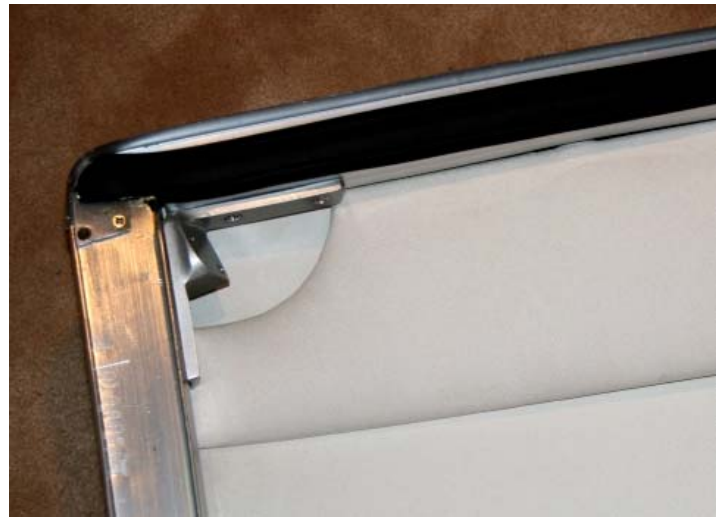
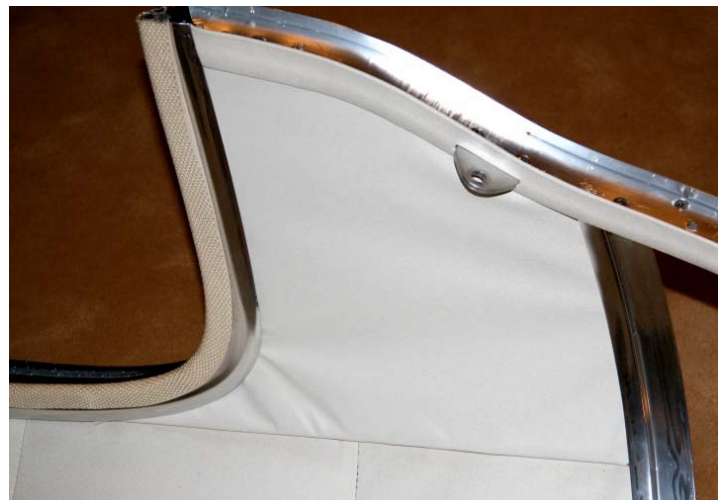
I was then able to flip the top over and install the front pad. The screws that fasten the front side braces needed to be withdrawn so that the triangular clip on the side of the front pad could be pushed into place between the two screw locations. The screws were then replaced. The front rail header seal, part number 27H9597, was then cut to fit and glued onto the rear edge of the front aluminum rail.

The rubber seals for the side rails were also trimmed and lightly glued in place. The windlace supplied by Bill Bolton was then pushed over the rubber seals and onto the side and front cant rail lips to create a nice finished look. One continuous piece of windlace was used to cover the rails. It is somewhat difficult to push it into place in the 90 degree corners. The front clasps were then screwed into the front corner brackets. I have these set as they were originally, but I expect the "J" hooks will need some adjustment when the top is put in place.

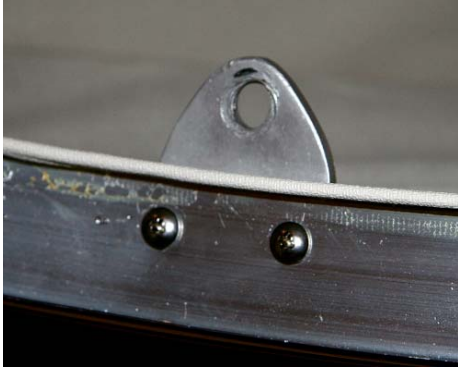
The hold down brackets that, along with large “J” hooks, clamp the hardtop to the cockpit were then inserted through the slots in the bottom cant rail and secured with two #10 truss head machine screws. I used the original quarter panel boards and recovered them with the headliner material. They were pushed into place and wrinkles were “massaged” out as much as possible.

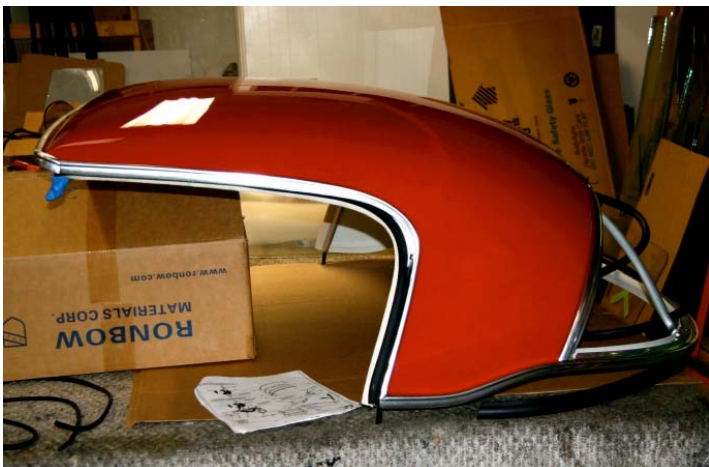
I managed to get the top to the glass shop without damaging it! The owner reviewed the plexiglass, the seals and proclaimed himself ready for the task.

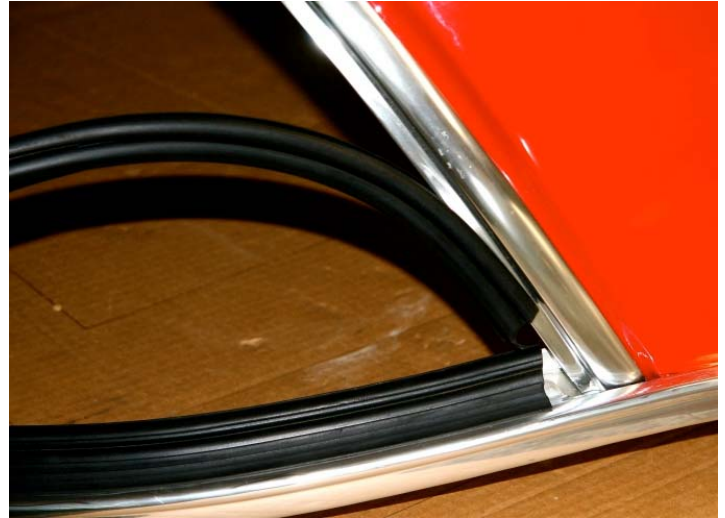
To get a feel for how the top and bottom seals would ultimately join together the installer slid the pieces together on the rails. The upper backlight glazing rubber was part number 27H9594. The lower glazing seal was part number 27H9595.

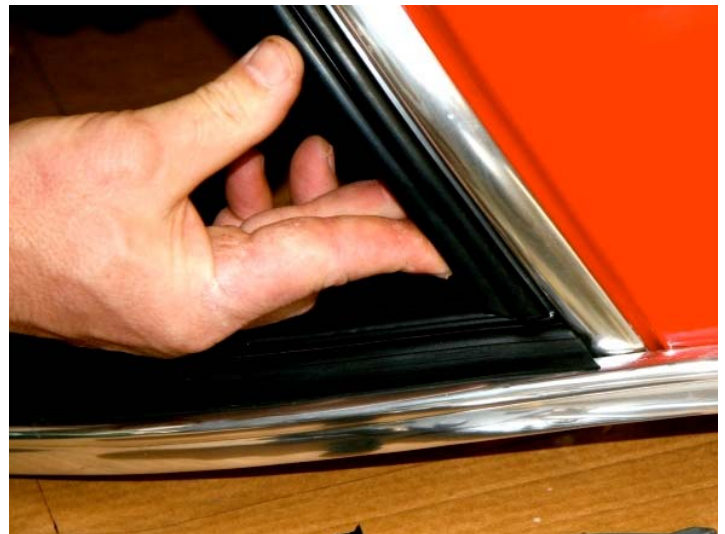
The iterative process of trimming both pieces began until he was eventually satisfied that the fit was as good as it was going to be. Of course, the second side, in this case the LH side was more difficult to fit. The key is to trim only a little at a time. You can always trim more, but if you go to far there is no recovering!

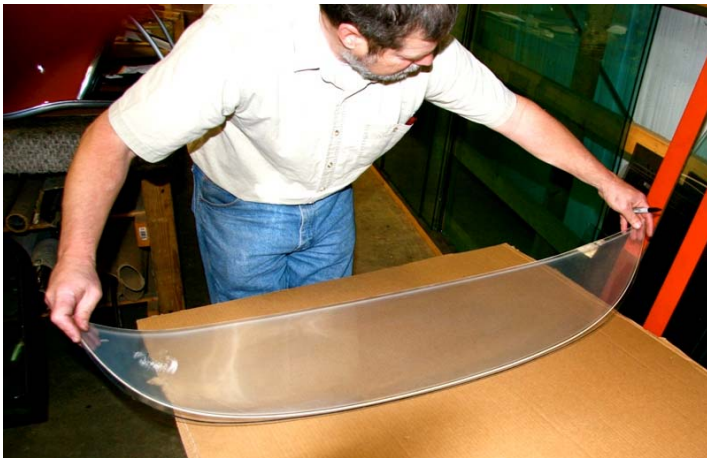
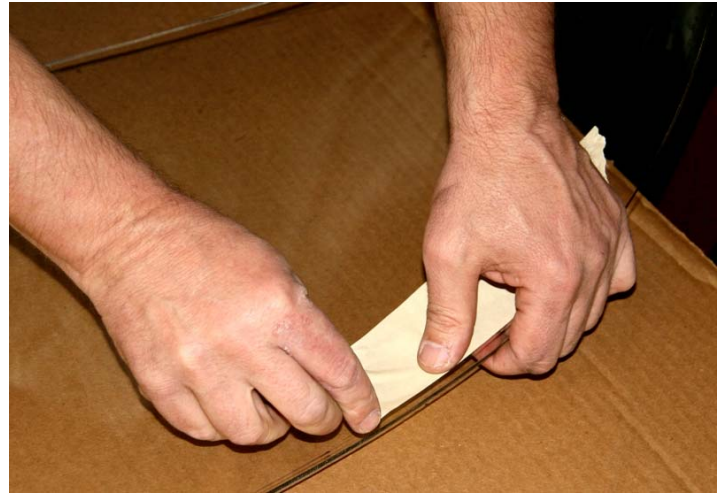
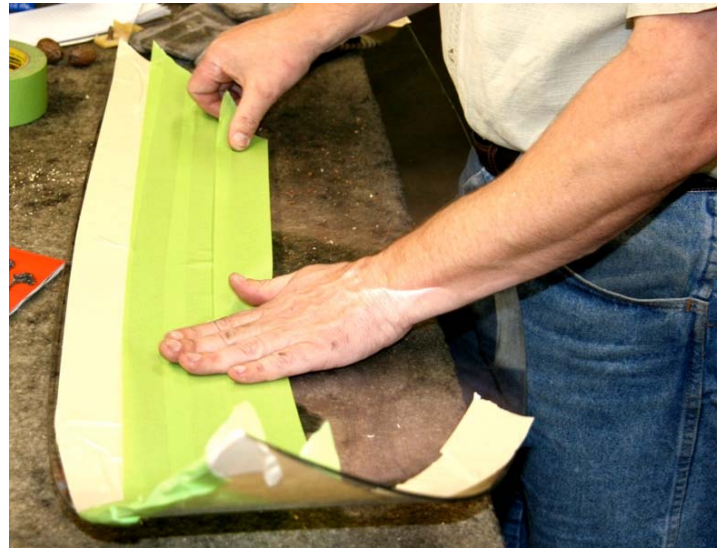
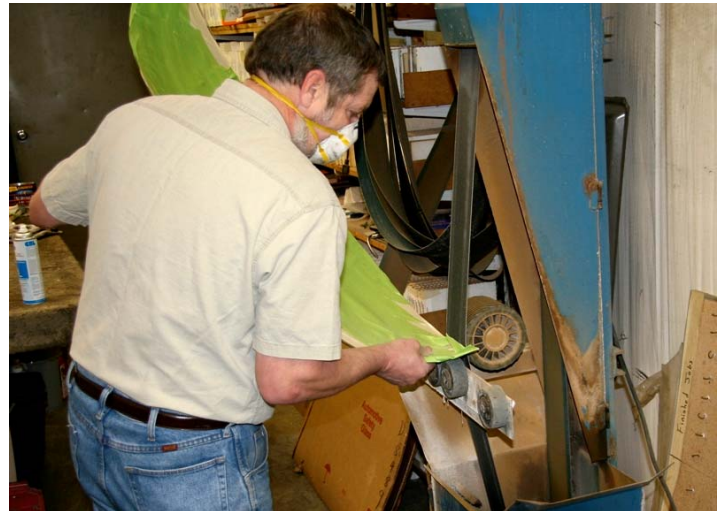
The installer used a silicon spray to temporarily soften and lubricate the rubber to make it easier to fit the plexiglass and the locking seal. Unfortunately, we discovered that my glass was not shaped properly.

I was able to compare it to my “foggy” original and one could see that trimming was required. As with the rubber, the rule was “a little at a time.” We taped the glass to mark the material to be removed and to avoid scratching it and then used a belt sander to gradually remove material. We repeated this process three times until satisfied with the fit.

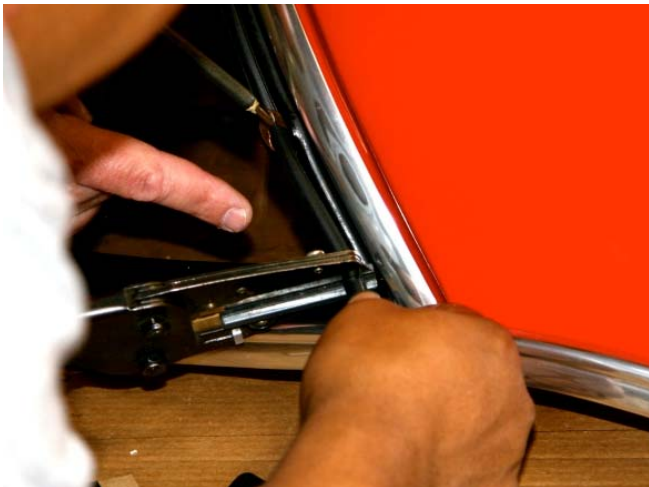
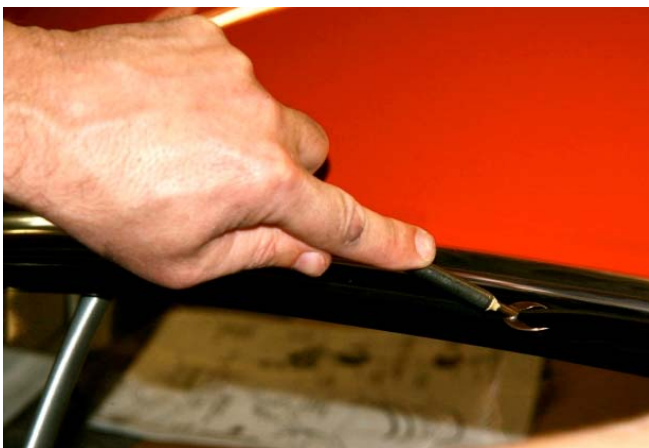
We experienced a little problem with the lower locking strip - it just did not want to “lock” on the bottom edge of the strip. The shop had another, slightly larger, strip that worked, but it had a chrome finish. I will paint the

chrome a matte black to look just like the rubber. The plastic tool in John's hand is known as a "bone."

These are a few images of the locking strip being "run in" to the larger seal. As always, the right tool for the job is key. John's assistant trimmed the locking strip to the proper length.

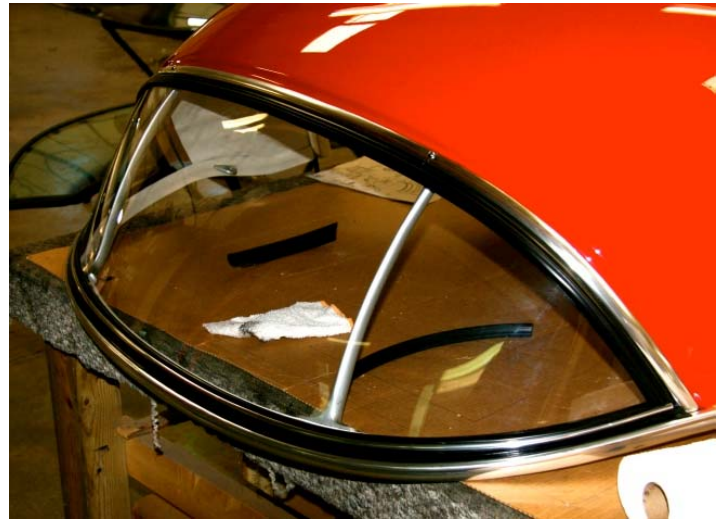
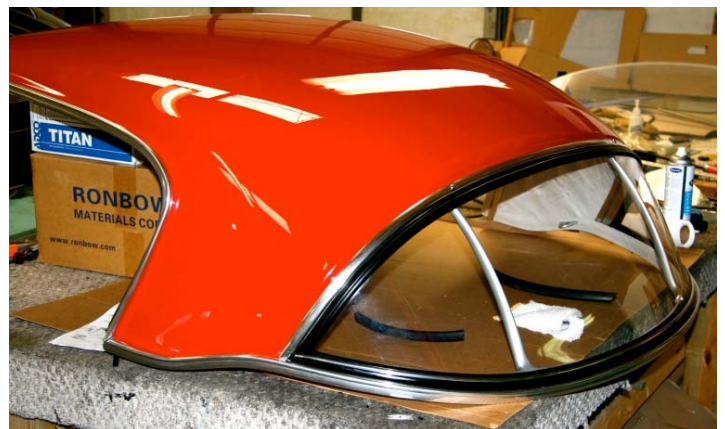
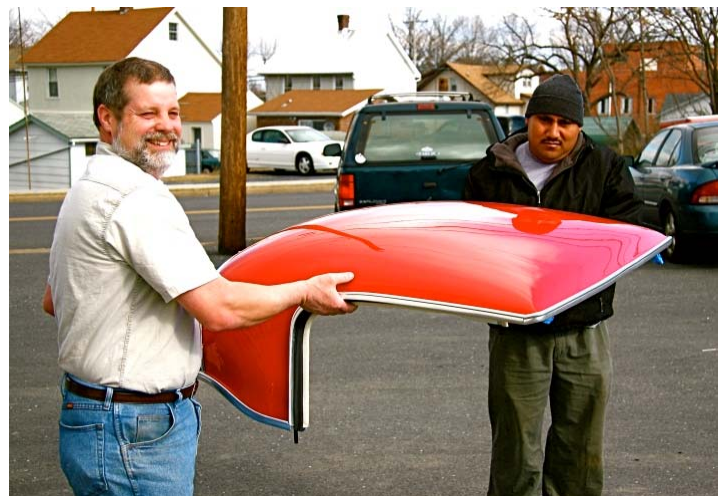
After installing the locking strips and cleaning up the silicone spray residue, the backlight installation was complete. Now, it is back home to put the seals on the bottom cant rail.

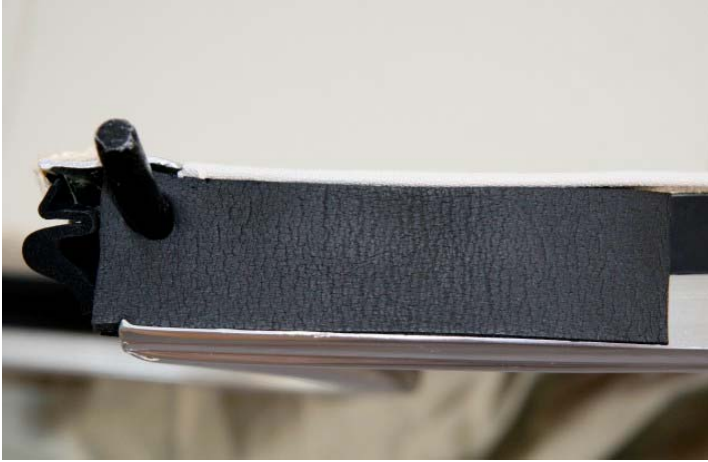
I believe the original spigot pin pad was 5" x 1/2" x 1 1/8" (27H9599). I did not have a replacement pad that met original specs, but I used 2 pieces of weatherstripping on each side that were 5" x 1/4" x 1 1/4". These pads were punched for the spigot pin and then glued together to make a pad similar to the original.

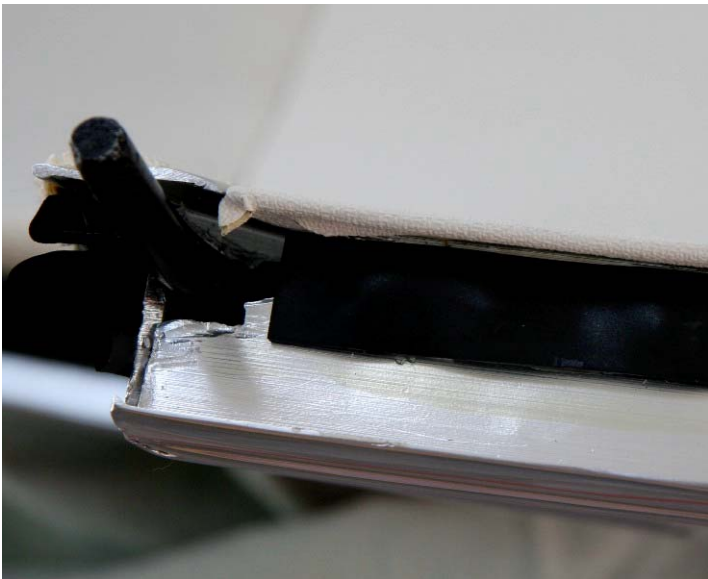
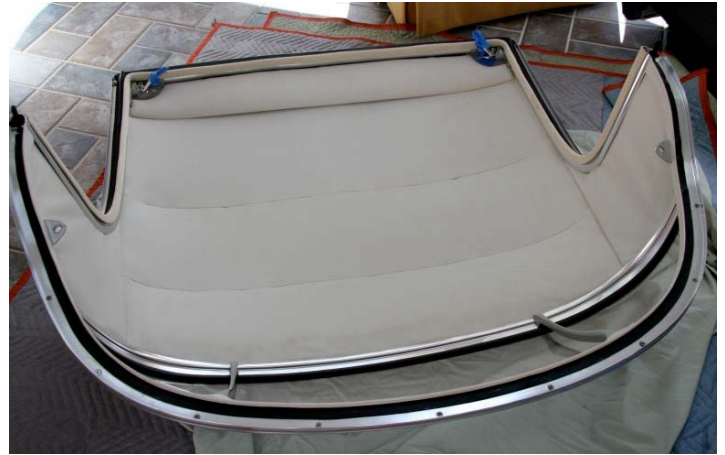
The narrow (3/4") packing strip for the bottom cant rail (27H9686), was then glued into place. The piece in the image below was cut off to butt against the spigot pin pad.

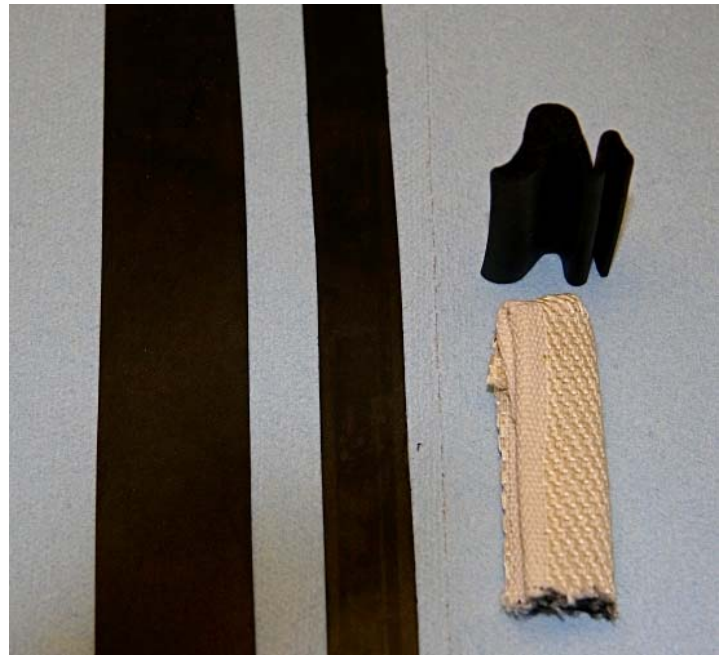
The wide (1 1/8") packing strip, to the left in the image at right, was glued over the narrow packing strip and it also was run to the back of the spigot pin pad. Then the header rail seal (27H9597) was lightly glued over the edge of the bottom rail and the windlace was pressed over it and the rail to give a finished appearance.

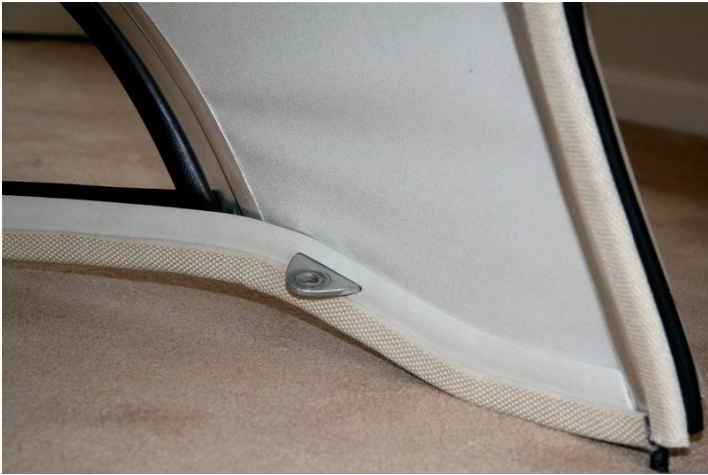
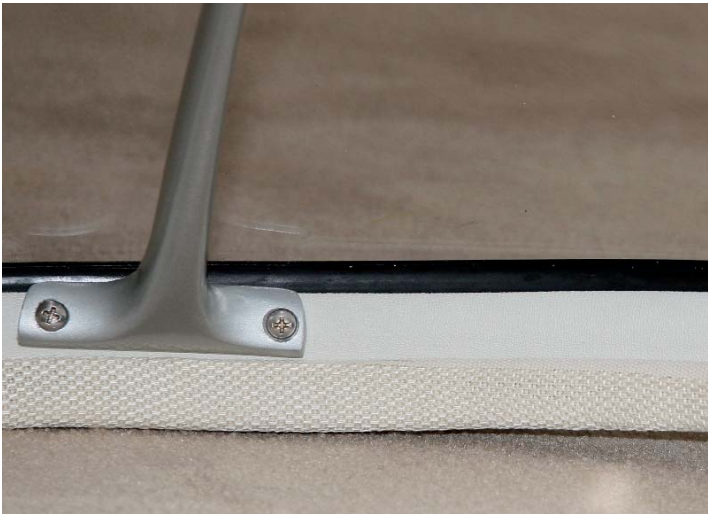
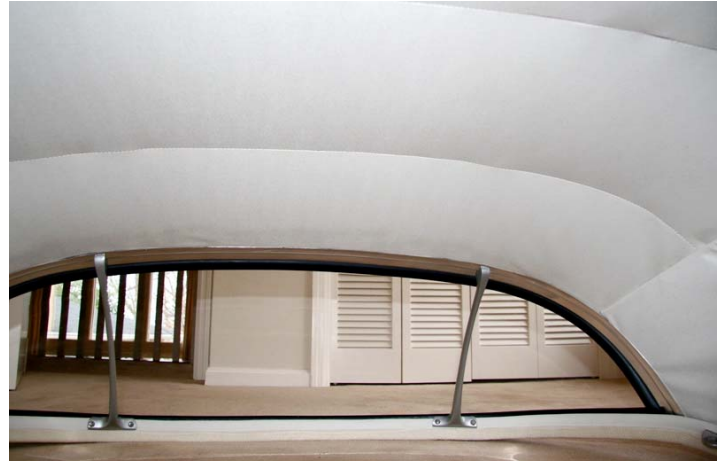
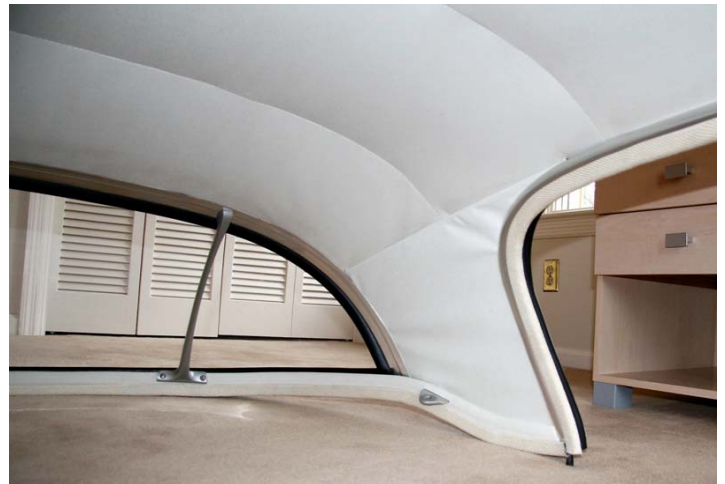
The finished job is seen in the images below. There were several things that could have been done a bit better, but isn't that always the case with the first time you do something? I was generally pleased with the results.
